DOT US Department of Transportation
PHMSA Pipeline and Hazardous Materials Safety Administration
OPS Office of Pipeline Safety
Eastern Region

Principal Investigator Alex Dankanich
Region Director Byron Coy
Date of Report November 12, 2014
Subject Failure Investigation Report – Buckeye Macungie Tank 228 Overfill

Failure Investigation Report – [Buckeye Pipeline – Tank 228 Overfill]

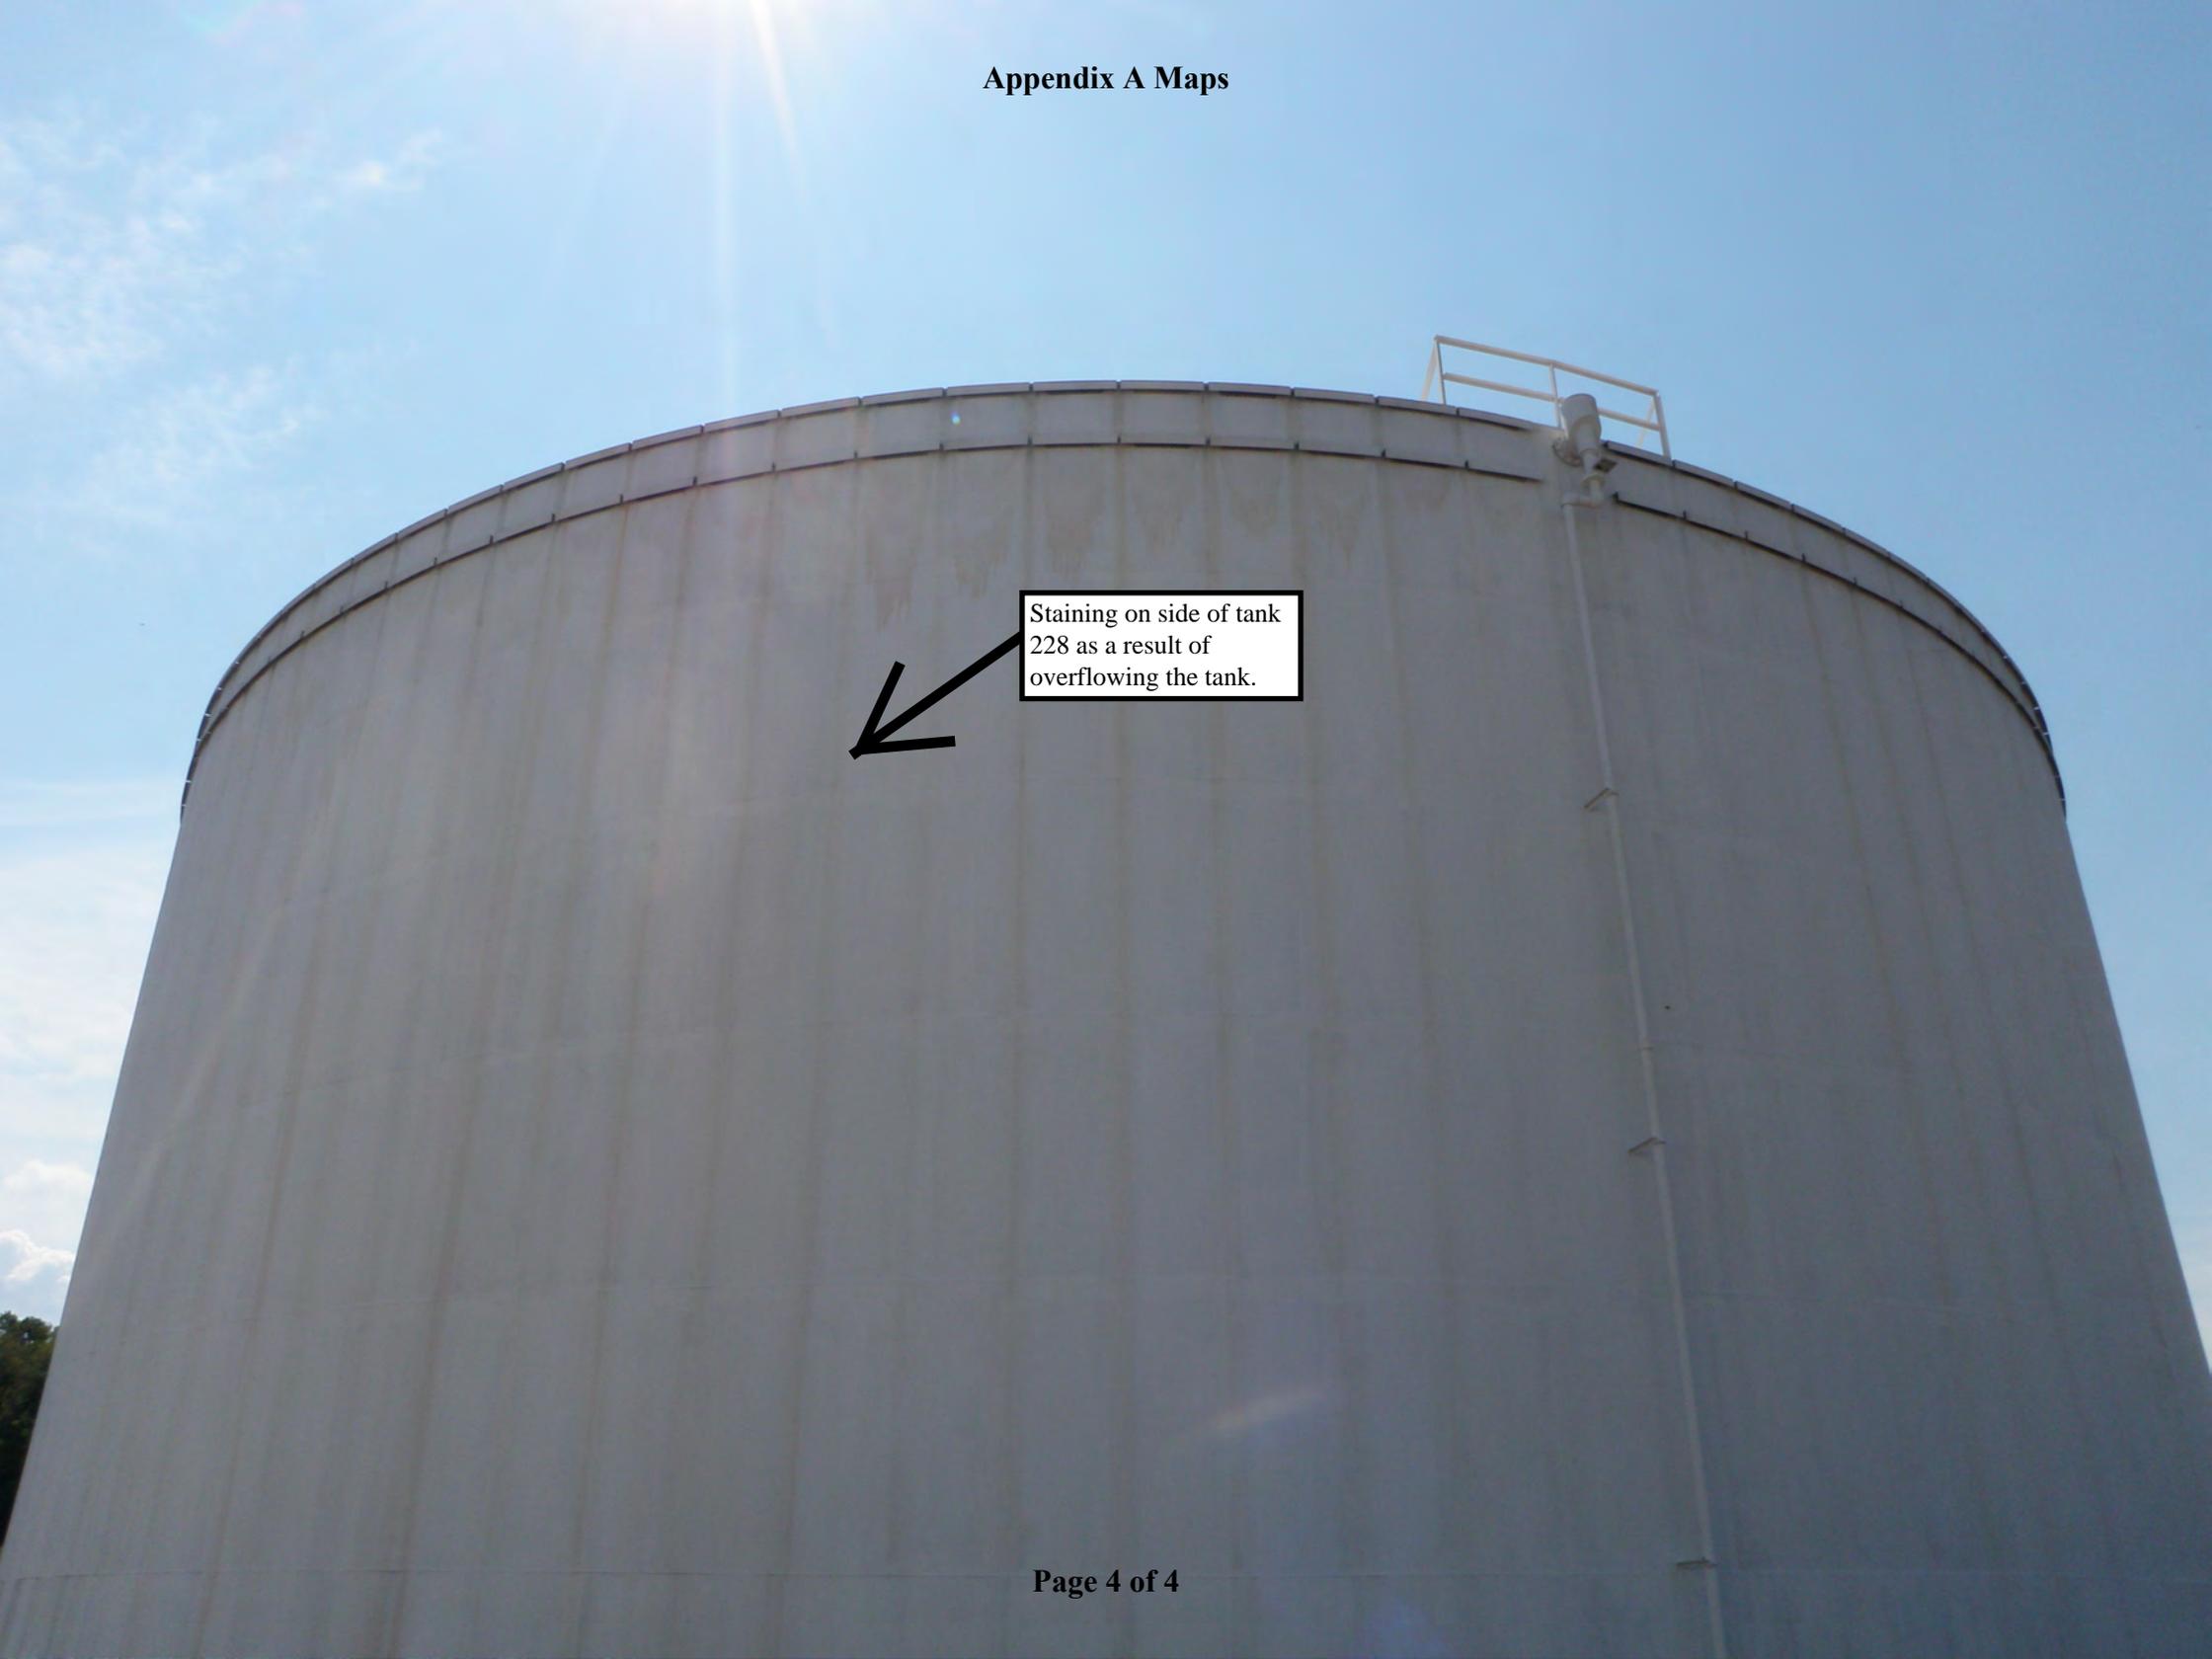
The overflow was caused by inaccurate calibration of the level gauging and alarm system on Tank 228. As a result, the Tank Side Gauge was reading approximately 18 inches lower than the actual product level in the tank. During the process of filling the tank on June 17, the control room operator received a “Safe Fill” and “Independent Hi-Hi Alarm” indicating that the safe fill level in the tank had been exceeded. Product flow was diverted to another tank. Shut down and volume calculations were conducted, which indicated a safe fill level and therefore a field inspection of the tank was not

The investigation revealed that the set points of alarms and the tanks gauging system had not been accurately set or checked for at least one year. The tank side gauge and the GSI tracking system were reading about 18 inches lower than actual levels in the tank. The independent Hi-Hi magnetrol alarm level was set 7 inches too high. As a result, the tank gauge was showing the tank level to be at “max safe fill” at the same time the Hi-Hi alarm was received and the tank was in an overfill condition.

2012 – June – As part of the Tank Overfill Investigation conducted by Buckeye, the Hi-Hi Alarm setting was measured at 49'0". Buckeye has confirmed that this setting was 7 inches above the correct setting of 48'5".

Staining on side of tank
228 as a result of
overflowing the tank.

Upon completion of the spill remediation activities, the tank gauge level and alarm levels for Tank 228 were recalculated and adjusted to the appropriate levels. Tank 228 was then placed back in service. All other tanks at the Macungie tank farm were also checked to ensure gauge and alarm level accuracy. Monitoring wells have been installed in the tank dike as part of the remediation effort. No other remediation activities are planned.

1. Tank Gauging Procedures
 - a. Reinstate Monthly Hand Gauging of all tanks at Macungie Station.
 - b. Reinstate hand gauging to verify accurate gauge level during maintenance events on the Tank Gauging system at Macungie Station.
2. Check and evaluate all individual tank gauging systems at Macungie Station to ensure proper tank levels are being read through to GSI and SCADA.
3. Include Independent Hi-Hi Alarm Setting Calculation Guidance in 195 O&M Manual F-37 as policy and procedure for checking and/or re-setting Hi-Hi Alarms.
4. Ensure that Macungie Station Operations Personnel are trained on OQ task 412, Tank Operations.
