Principal Investigator Darren Lemmerman/Brian Pierzina
Senior Accident Investigator Karen Butler
Region Director Ivan Huntoon/Allan Beshore
Date of Report 07/30/2015
Subject Failure Investigation Report – Enbridge Energy, Limited Partnership –
Material Failure – Longitudinal Seam

Failure Investigation Report – Enbridge Energy, LP – Material Failure (Longitudinal Seam)

Failure Date 01/08/2010

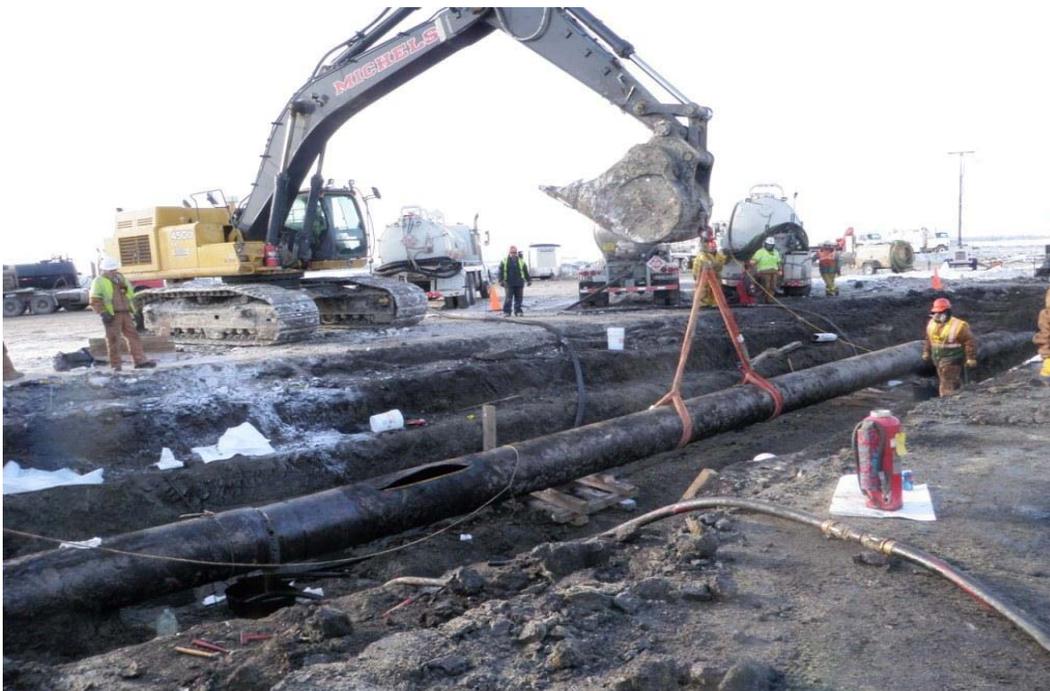
A 44-foot section of pipe including the ruptured portion was replaced with pretested pipe. The failed pipe was transported to an independent laboratory for metallurgical evaluation. The results of the metallurgical analysis indicate the failure was caused by a crack approximately 5.5 inches long which initiated at the toe of the longitudinal seam from the inside of the pipe, and grew in service (through cyclic fatigue) until failure. The peak depth of the crack at the time of failure was approximately 75% of

the pipe wall thickness. The longitudinal seam exhibited peaking/misalignment in the area of the defect from original manufacturing, which contributed to the failure. The chemical composition and metallurgical properties of the pipe material were consistent with the minimum specifications for API 5L X-52 in place at the time of manufacture.

Failed Pipe Section Being Removed
