**Enbridge Energy, Limited Partnership**

**Line 6B Integrity Verification and  
Remedial Work Plan**

**Prepared for  
Pipeline and Hazardous Materials Safety Administration  
(PHMSA)**

**September 26, 2010**

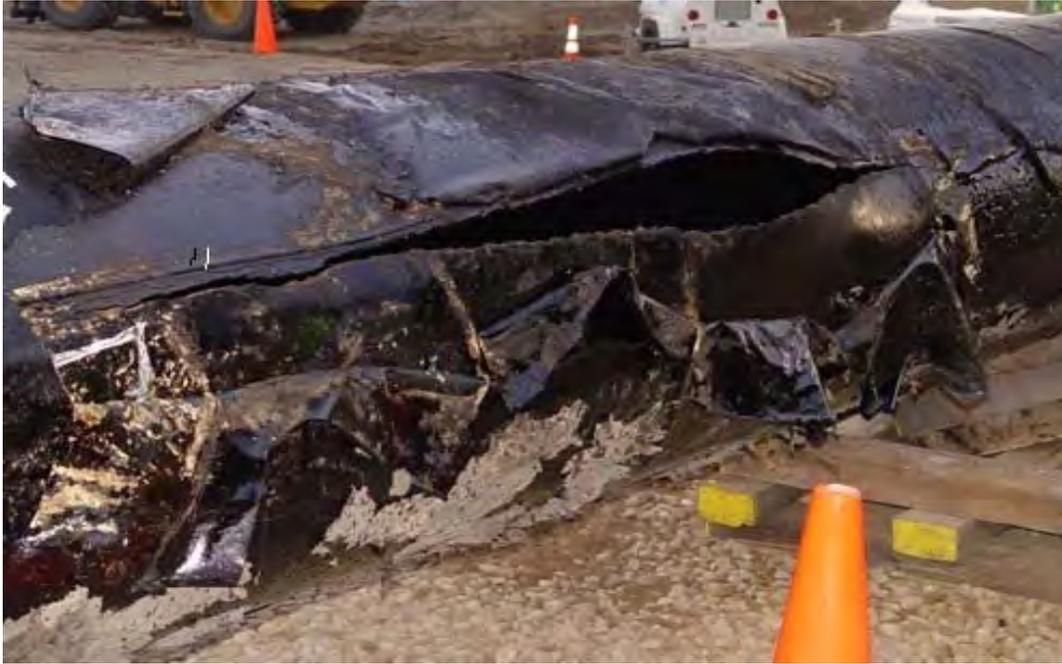
**Figure 1 – Failed Pipe Section**

On July 26, 2010 Enbridge discovered that a rupture had occurred on Line 6B resulting in the release of what has been initially estimated to be approximately 19,500 barrels of crude oil. The failure occurred at Mile Post 608, approximately one mile south of the town

of Marshall, Michigan. The section of Line 6B that included the failure segment was removed and a new section welded in place. The NTSB took custody of the section of pipe removed and is currently investigating the cause of the failure, as noted above.

Prior to the excavation of the failed pipe section, a close interval cathodic protection survey was completed. The level of cathodic protection was found to meet the requirements.

The pipeline was also examined for 50 feet on either side of the failed section for corrosion, coating conditions, and other issues that can be identified through external physical inspections. The review also involved correlating the observed conditions with previous ILI inspection data. No unusual conditions were identified and all areas were determined to be acceptable with no repairs required.

Upon completion of the above examination, a 51 foot section of new pipe was installed to replace the failed section. The pipe installed was manufactured by JFE Steel Corporation and met API 5L, Grade X-70, 0.375-inch wall thickness specifications. The details of Enbridge's examination and repair processes were submitted to PHMSA for review and approval on August 31, 2010.

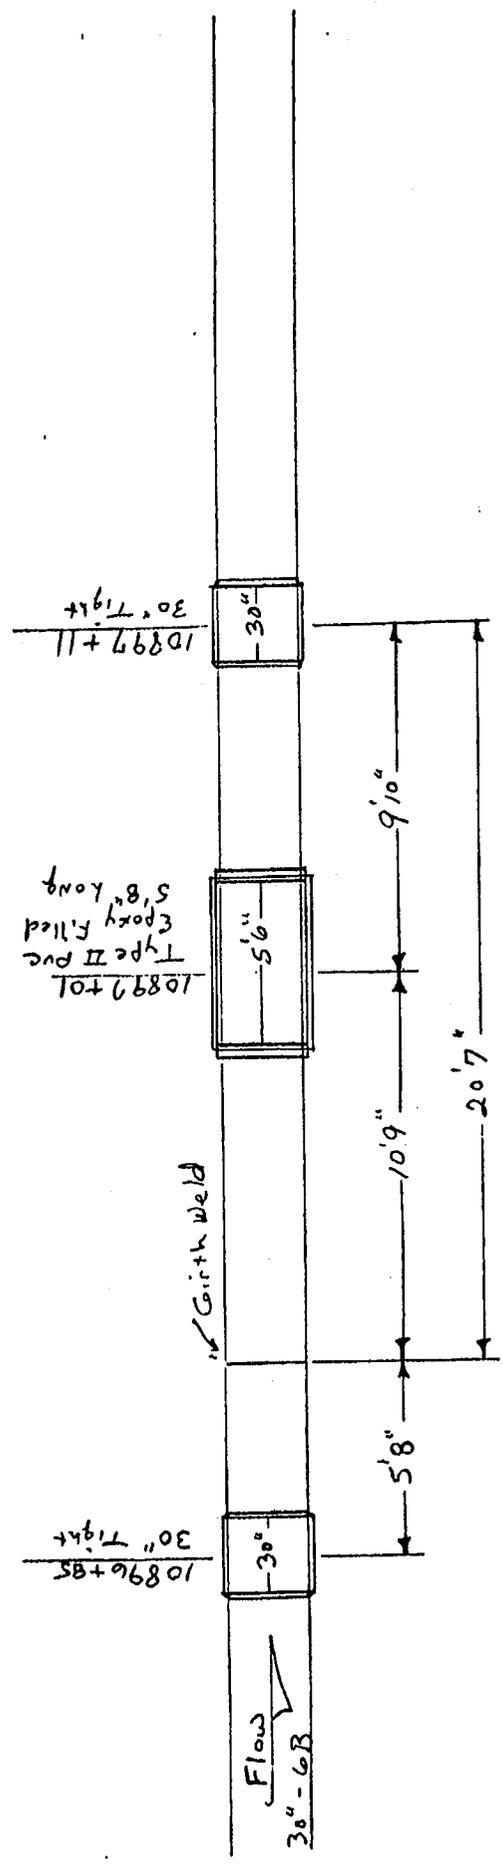
CORROSION INSPECTION REPORT

Once excavated, Enbridge records note the direct cause of the release was external corrosion with dimensions of 2” longitudinal by 1” circumferential.

**E. Apparent Cause of Incident:** External Corrosion. An area of external corrosion approximately 2" long X 1-1/2 " circumferential had developed at the 6:00 o'clock position on the pipe, 20 ft 6" downstream of the circumferential weld. The longitudinal seam on this joint was 1" left of the 12:00 o'clock position.

**J. Description of leak repair in detail:** A 14" Plidco was bolted in place for temporary repair and completed at 15:45 MST, June 26, 1995. Line 6B was restarted at 15:55 MST. The rest of the joint is being excavated to examine for any further anomalies. A permanent repair is scheduled for July 7, 1995. Tentatively plans are to remove the Plidco and install a leaking defect sleeve.

MP 6719 7-6-95 7-6-95 welded Fillets To pipe  
 CP 1.35 Hole CP - 1.35 7-7-95 Welded over sleeve + MAC Particulate

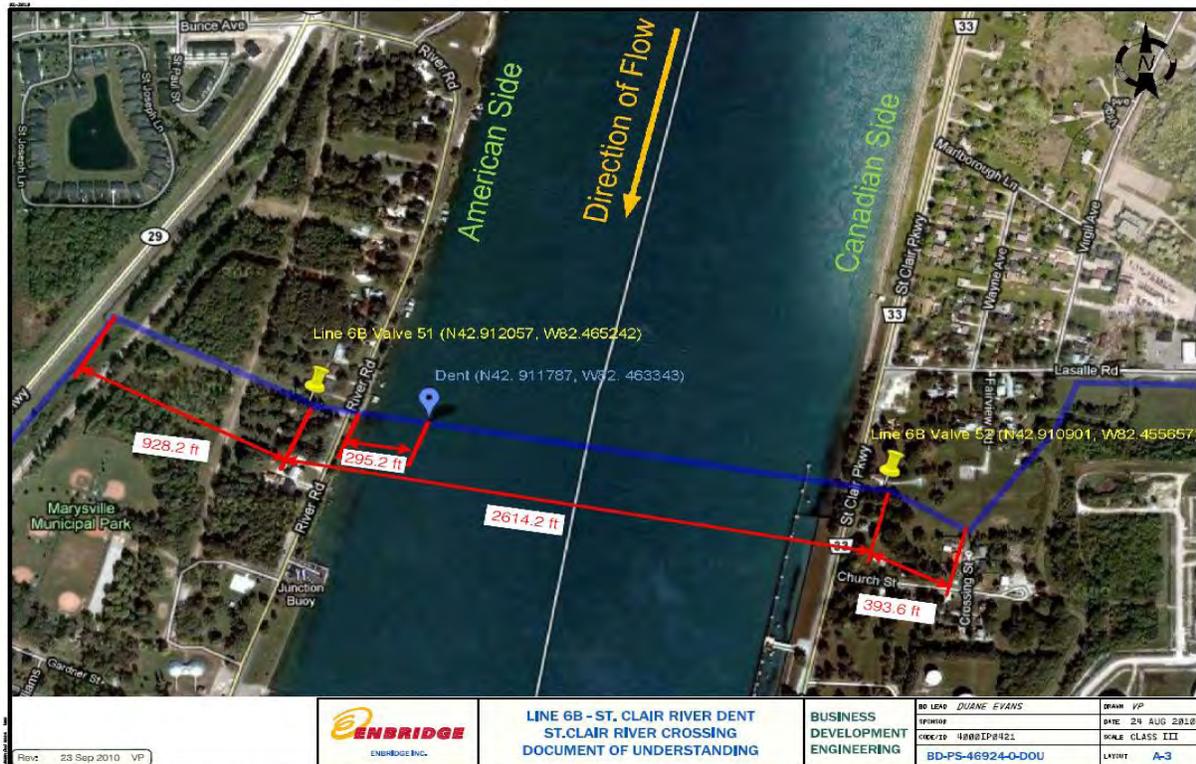
Figure 2 St. Clair River Crossing

The dent location at MP 751.33 is approximately 15 feet under the river bed (depth of cover) and includes pre-designed protective layers of gravel, boulders, construction spill pile backfill and silt. The depth of water at the dent location is approximately 30 feet. An underwater inspection undertaken by a diver of the entire crossing was completed on December 21, 2007. This inspection concluded that there was no evidence of disturbance or shallow cover anywhere along the crossing location.
