# Virginia

## 2008 Inspection Activities

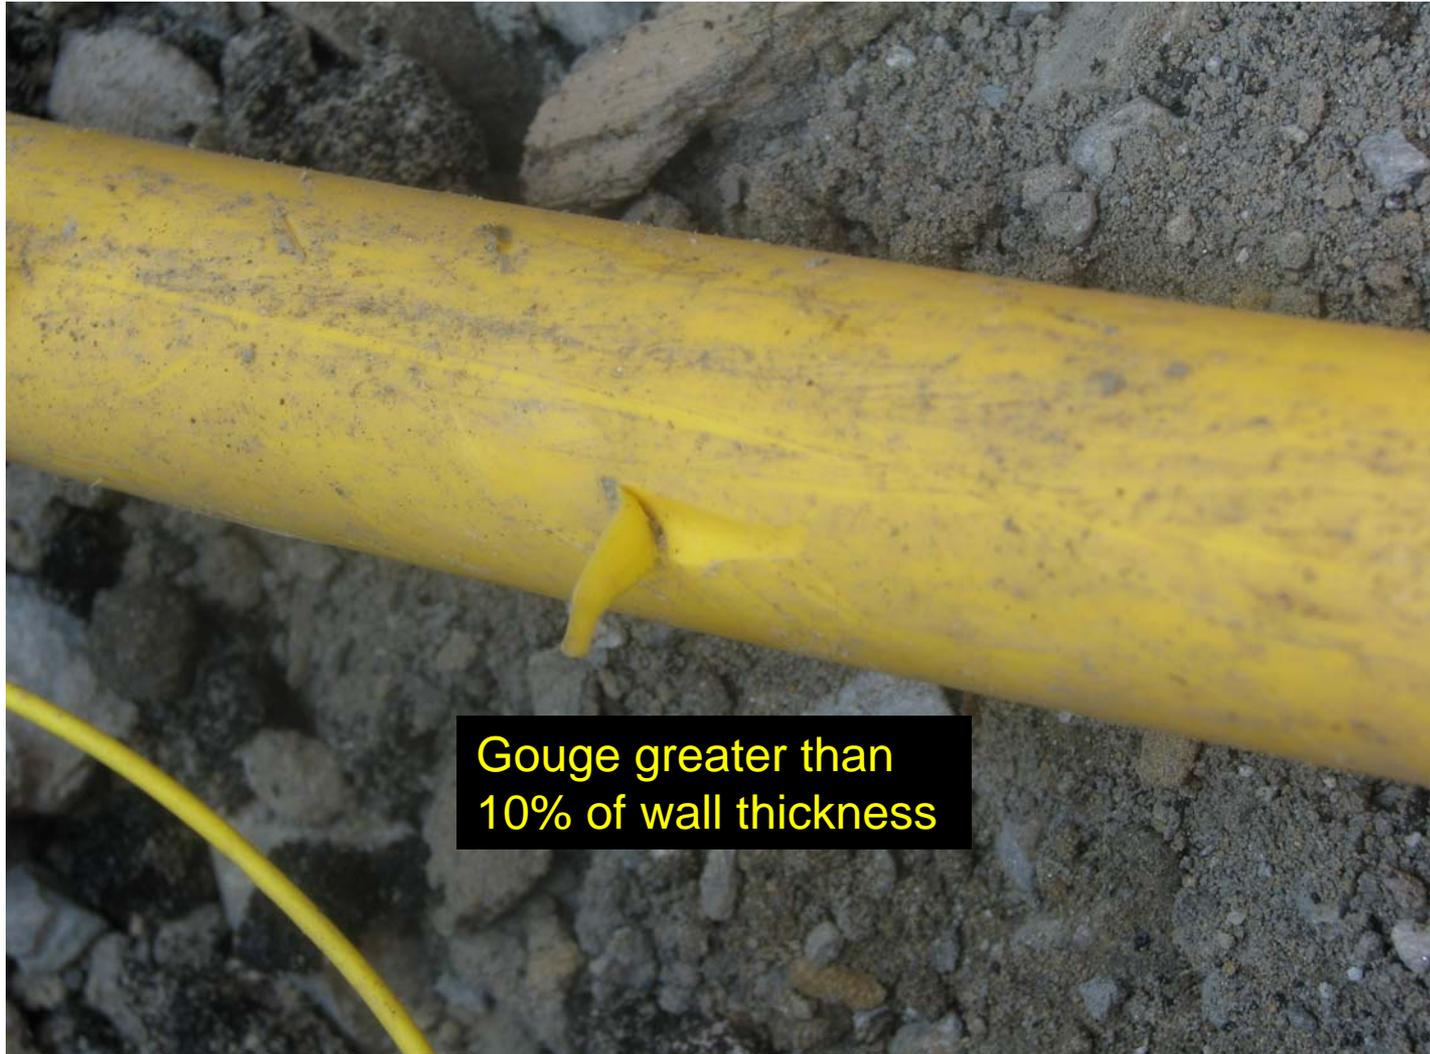
§192.59(a)(5) - Failure to install a service line that is free of defects.

Gouge greater than  
10% of wall thickness

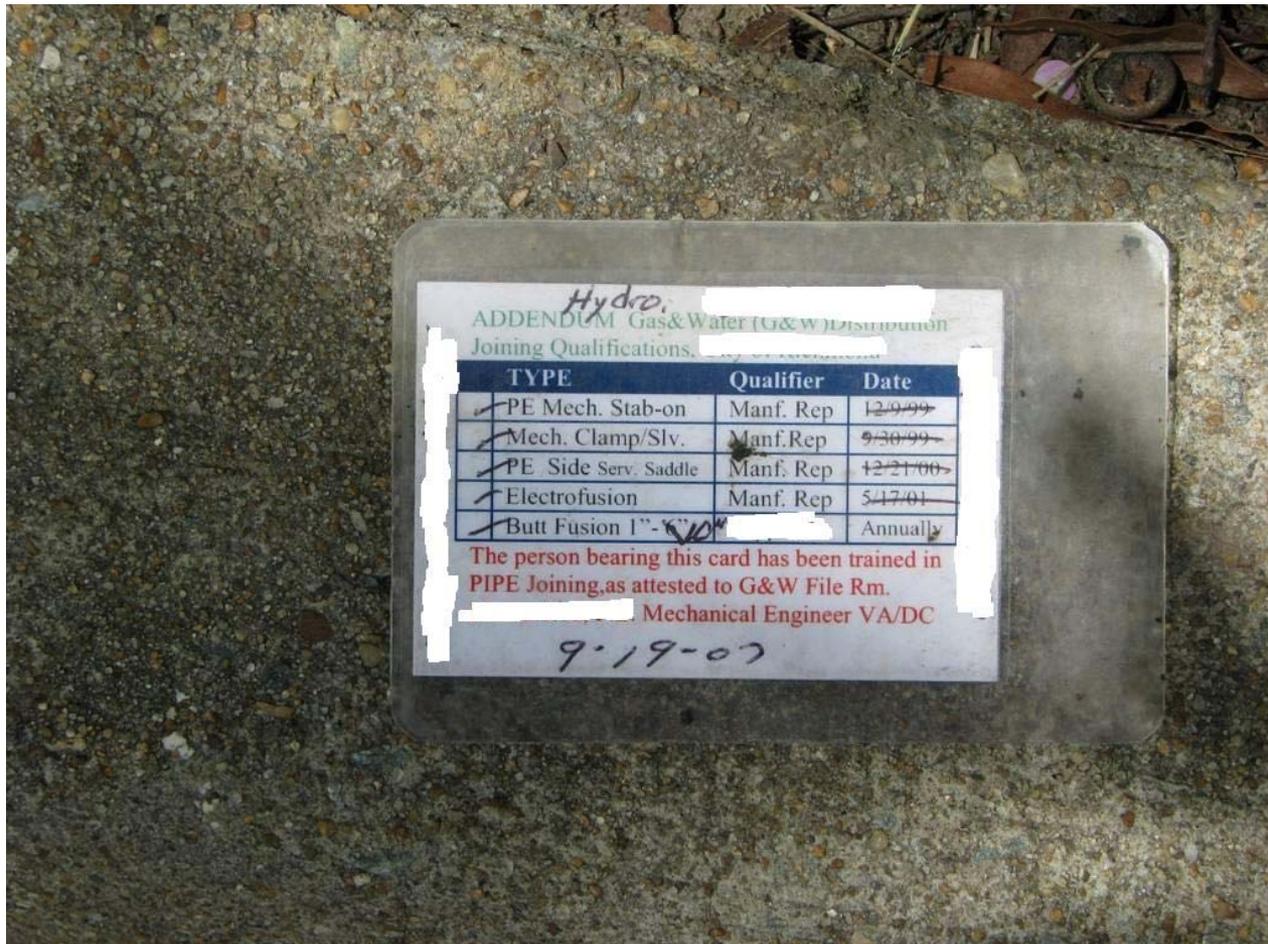
§192.285(c)(1) - Failure to re-qualify an individual to perform joining.

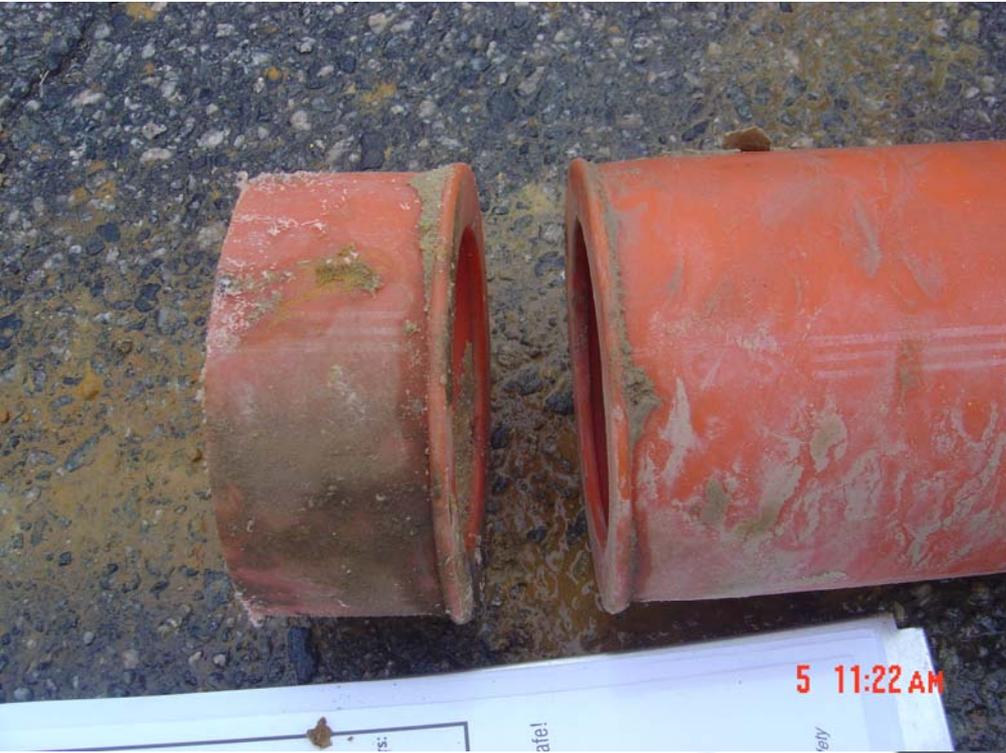
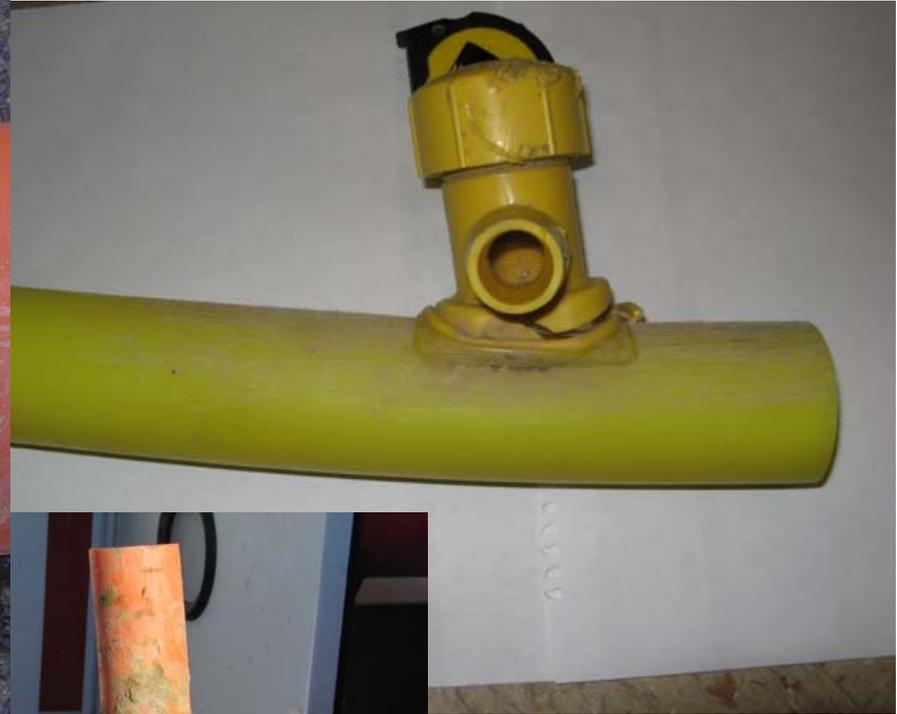
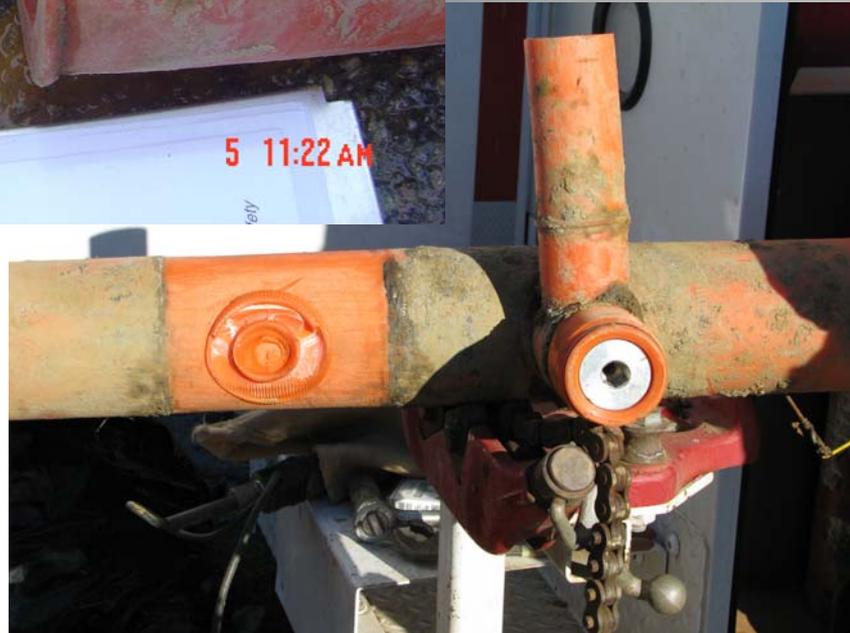
§192.303 - Failure to construct a main in accordance with comprehensive written specifications.

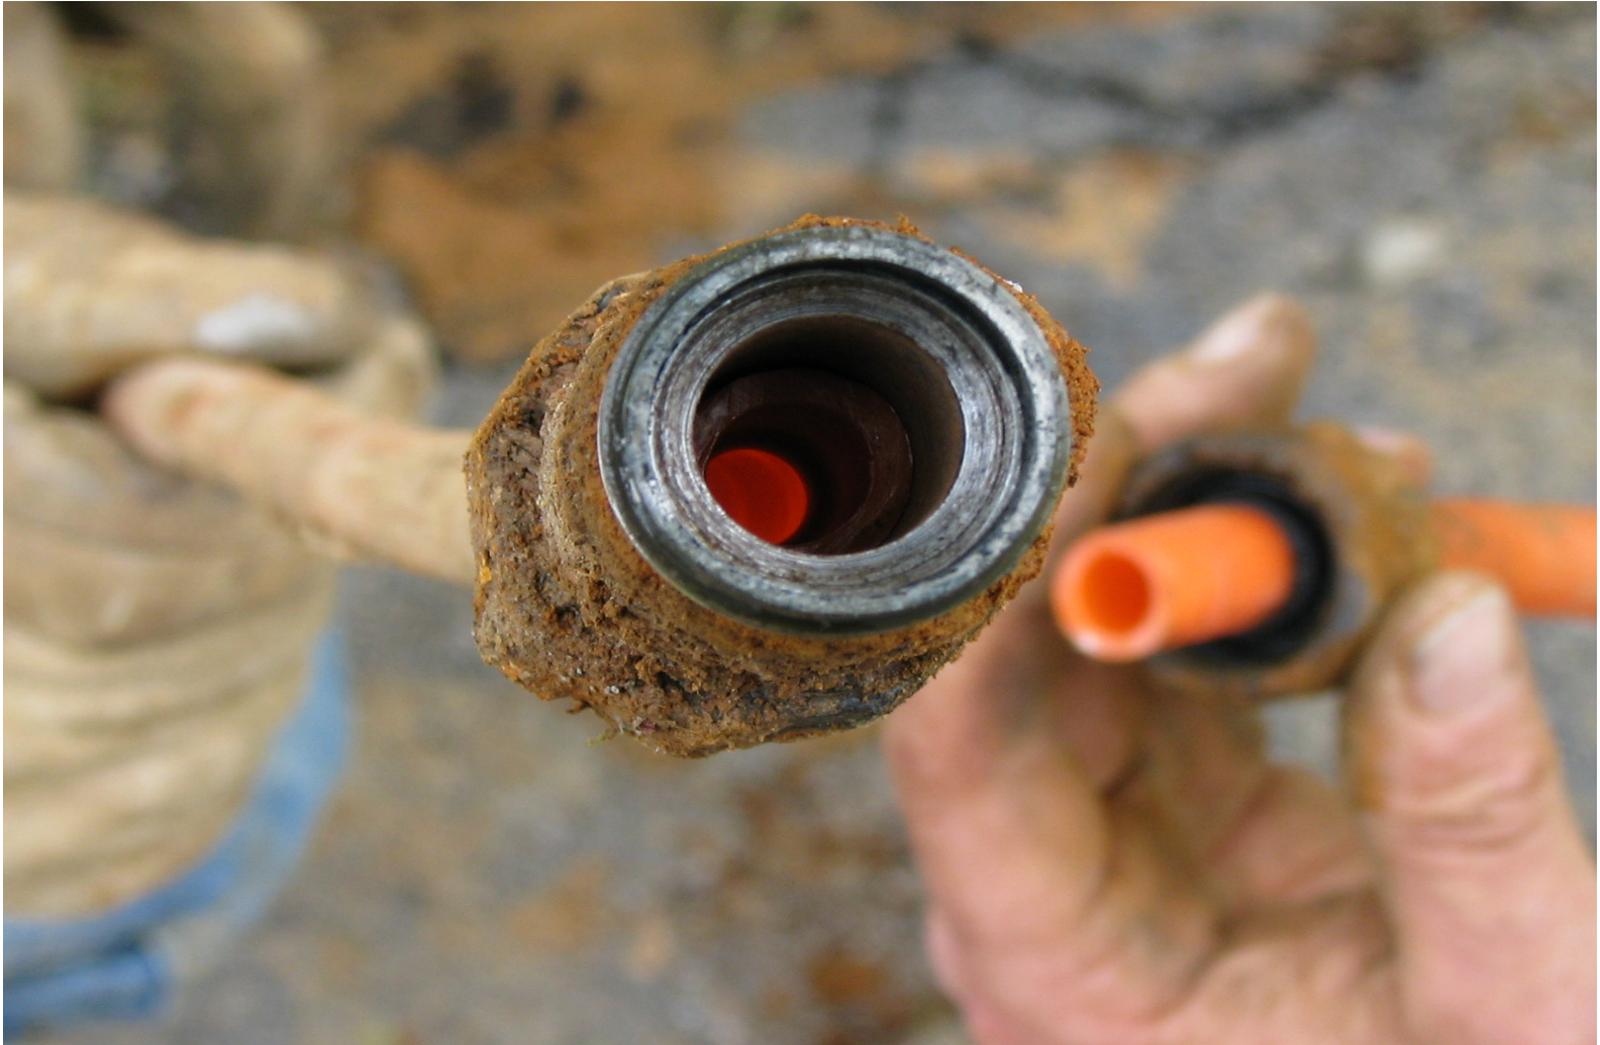
§ 192.281(e)(2) – Failure to use a rigid internal tubular stiffener, other than a split tubular stiffener, in conjunction with a coupling on plastic pipe.

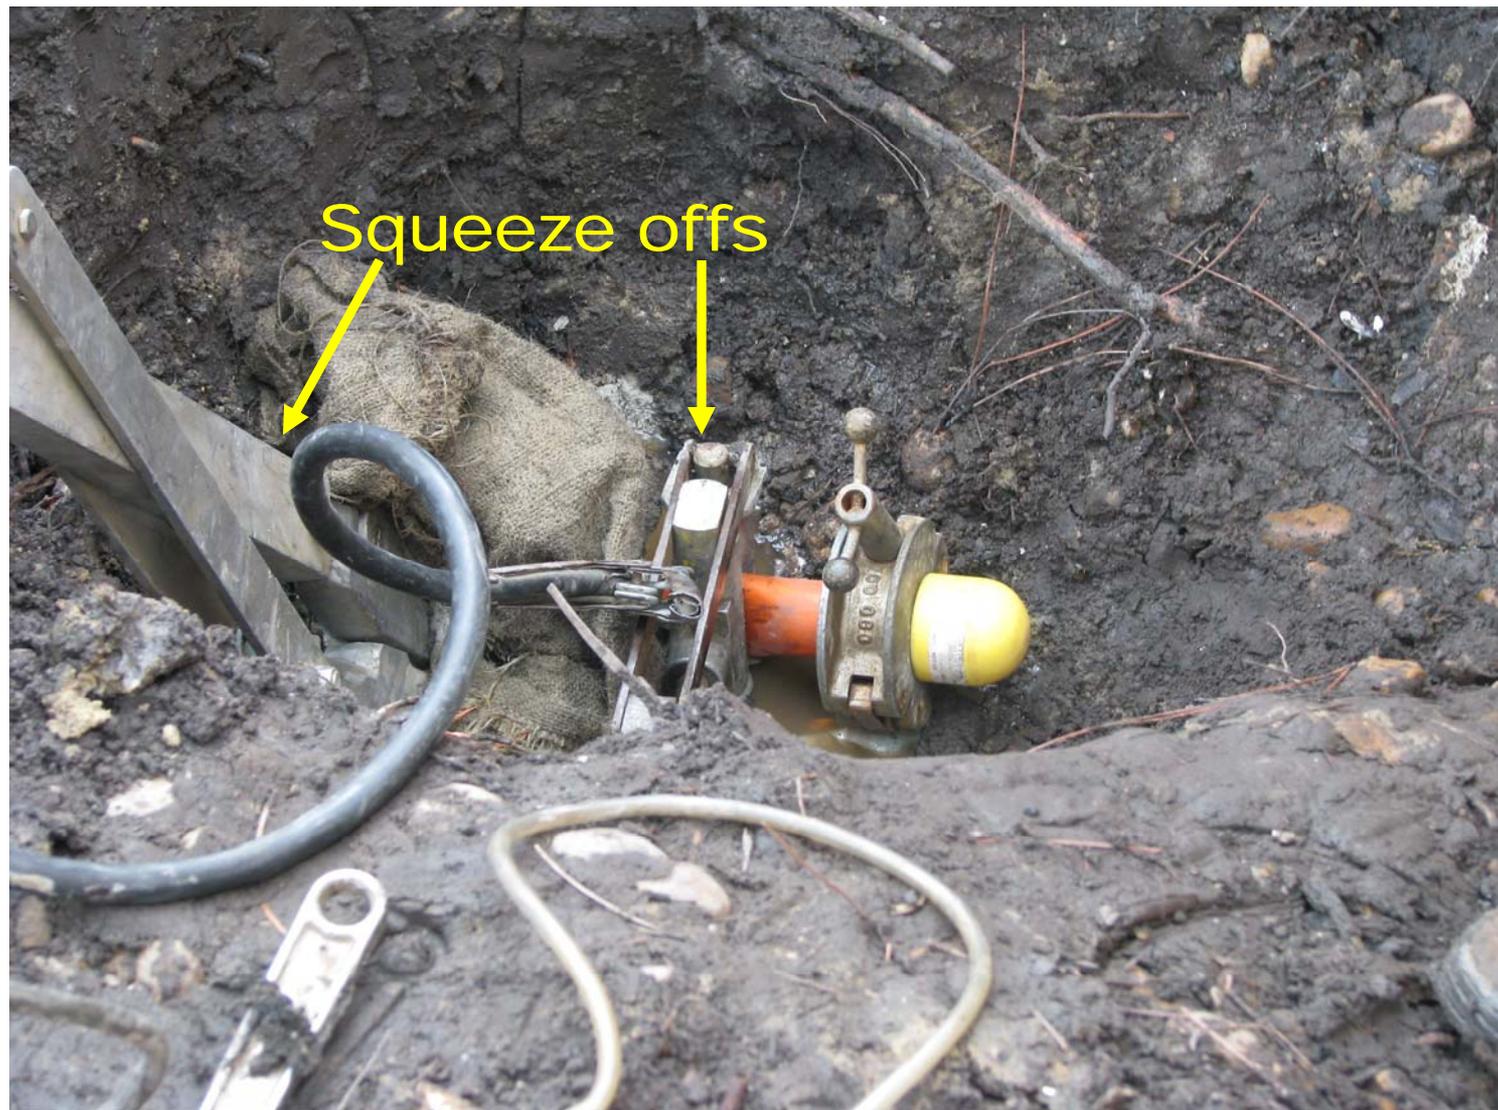
§192.605(b) - Failure to have adequate procedures for squeezing off a pipeline.

- The squeeze off tool must be at least 3 pipe diameters, or 12 inches, whichever is greater, away from any butt fusion, or any socket, saddle, or mechanical fitting.

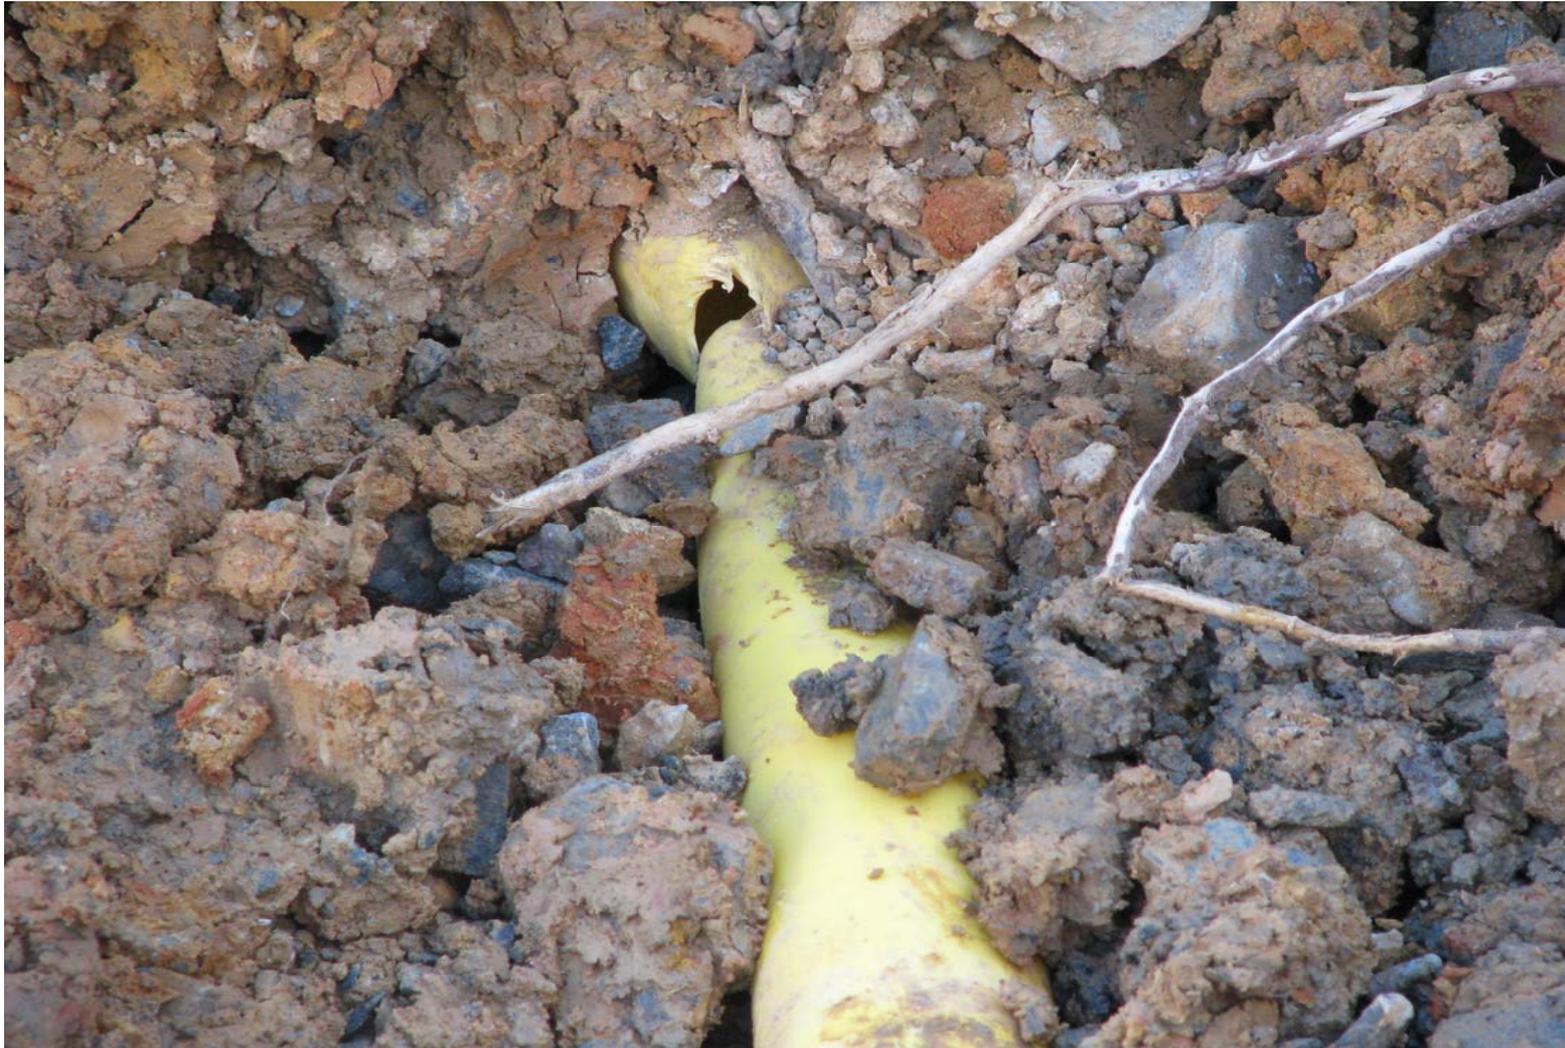
§192.303 - Failure to construct a main in accordance with comprehensive written specifications by not following the backfill requirements.

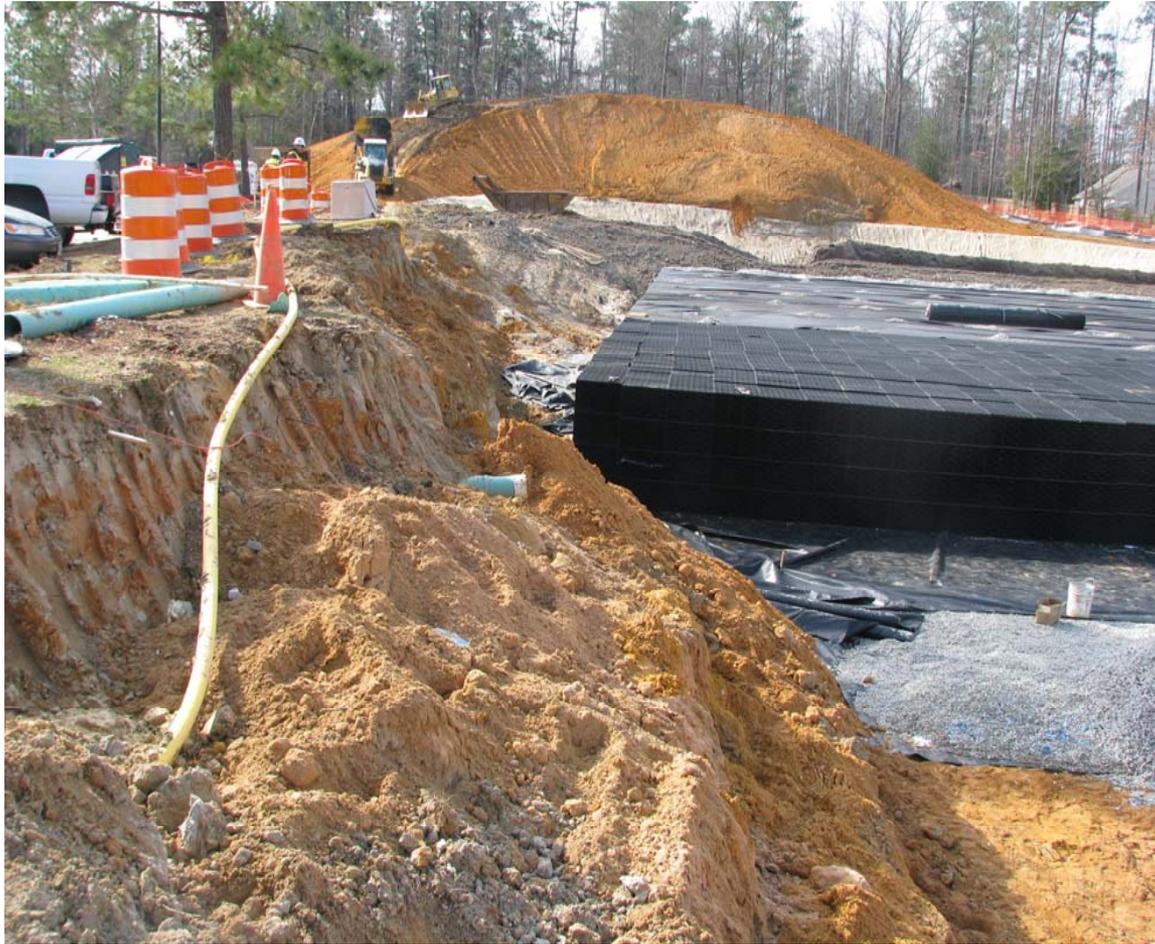
§ 192.614(C)(6)(i) – Failure to conduct inspections as frequently as necessary to verify the integrity of the pipeline.

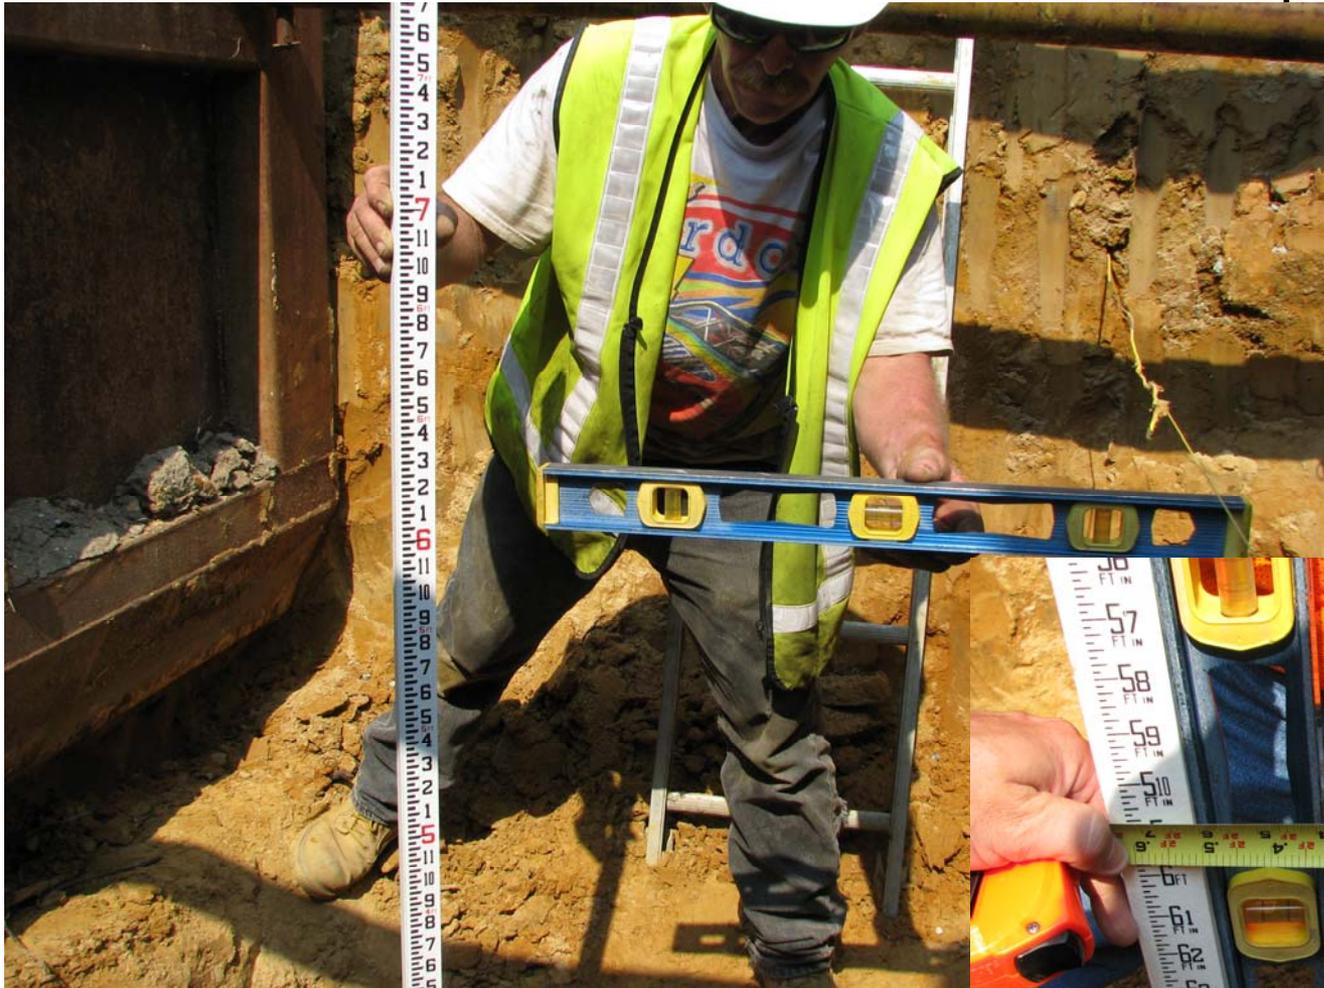
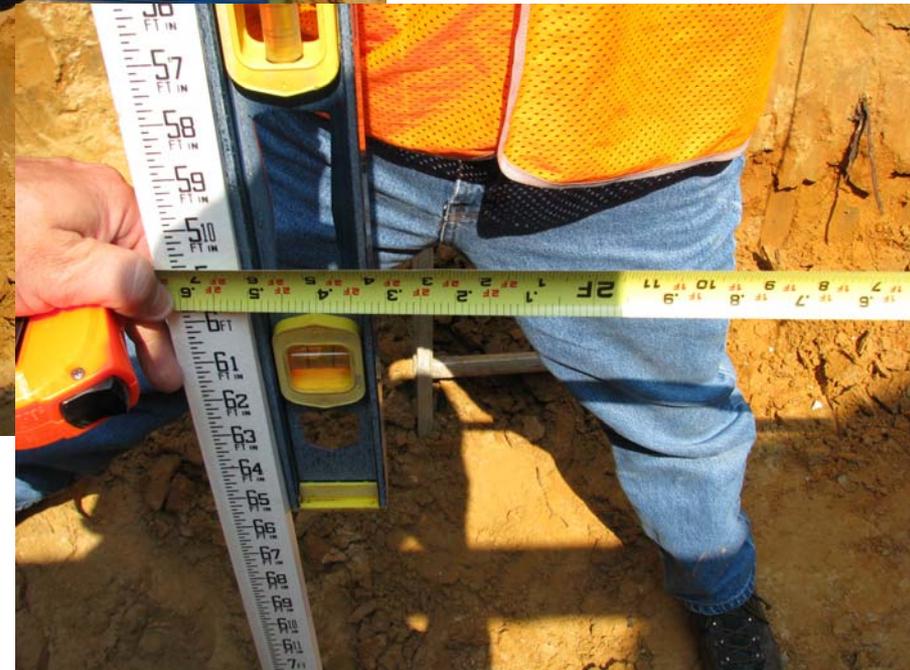
## Distance from tracer wire to pipe

Tracer wire located  
31 inches  
horizontally and 6  
feet, 3 inches  
vertically from the  
pipe

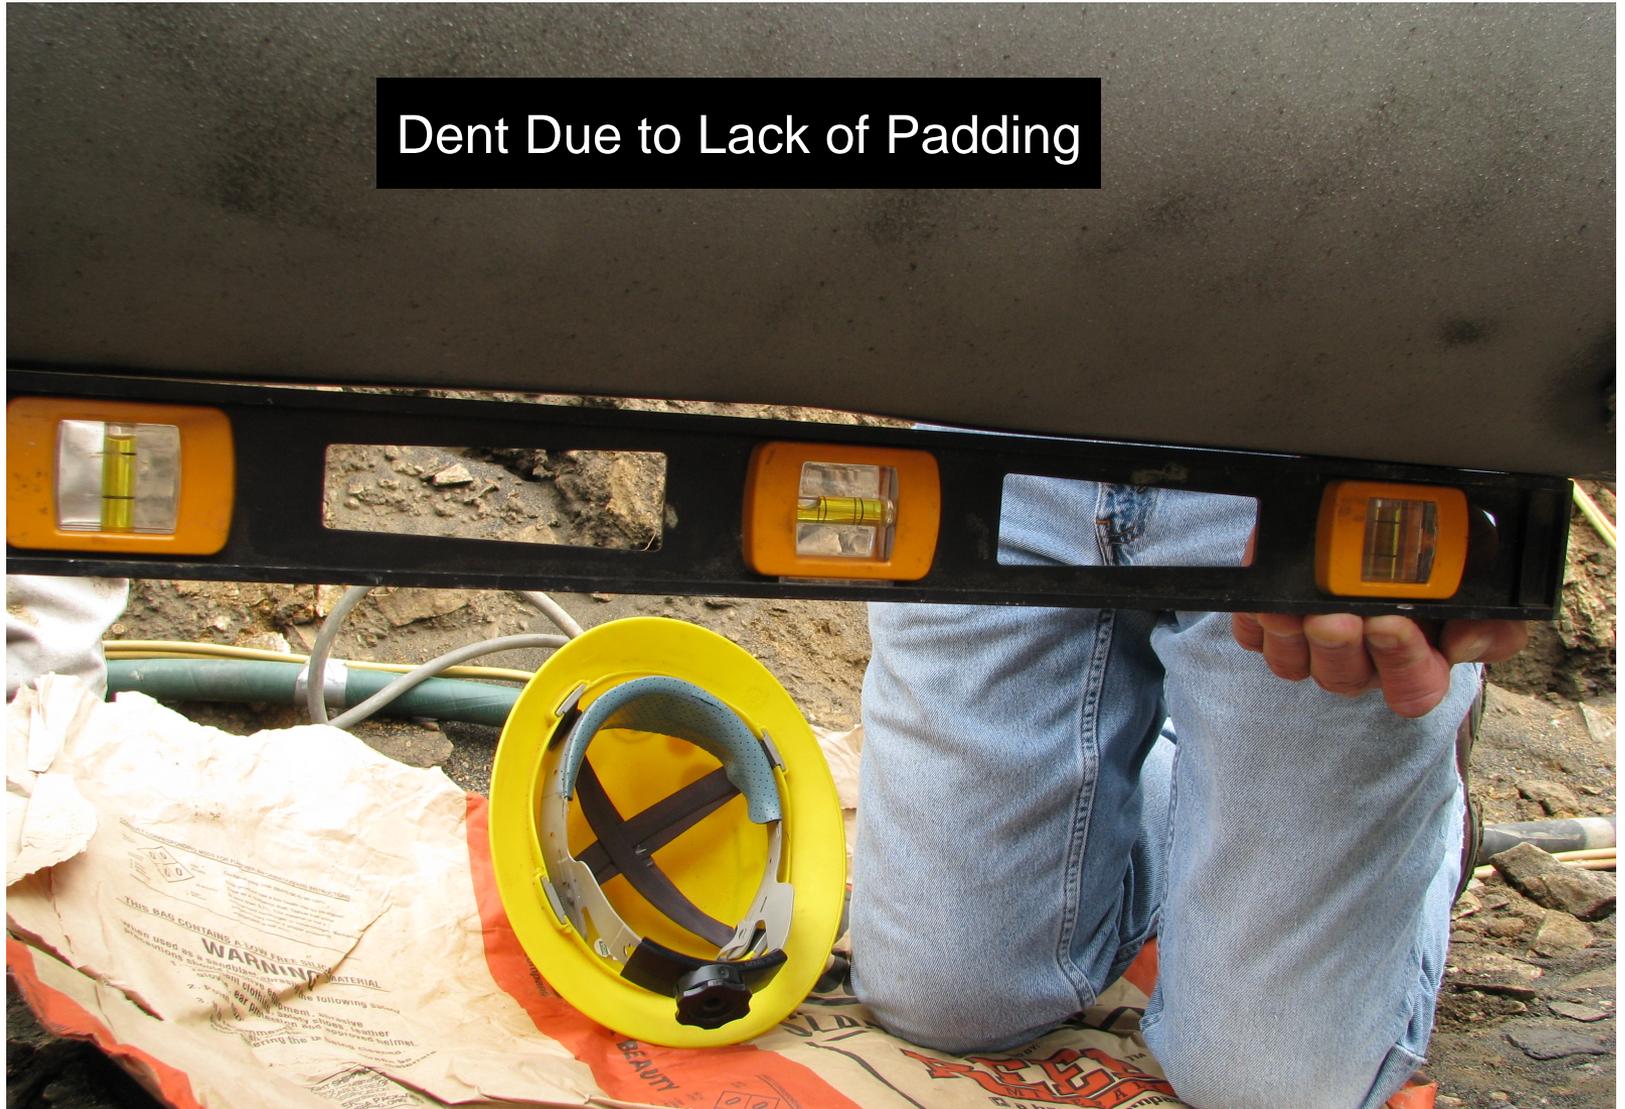
§192.303 - Failure to construct a main in accordance with comprehensive written specifications.

Dent Due to Lack of Padding

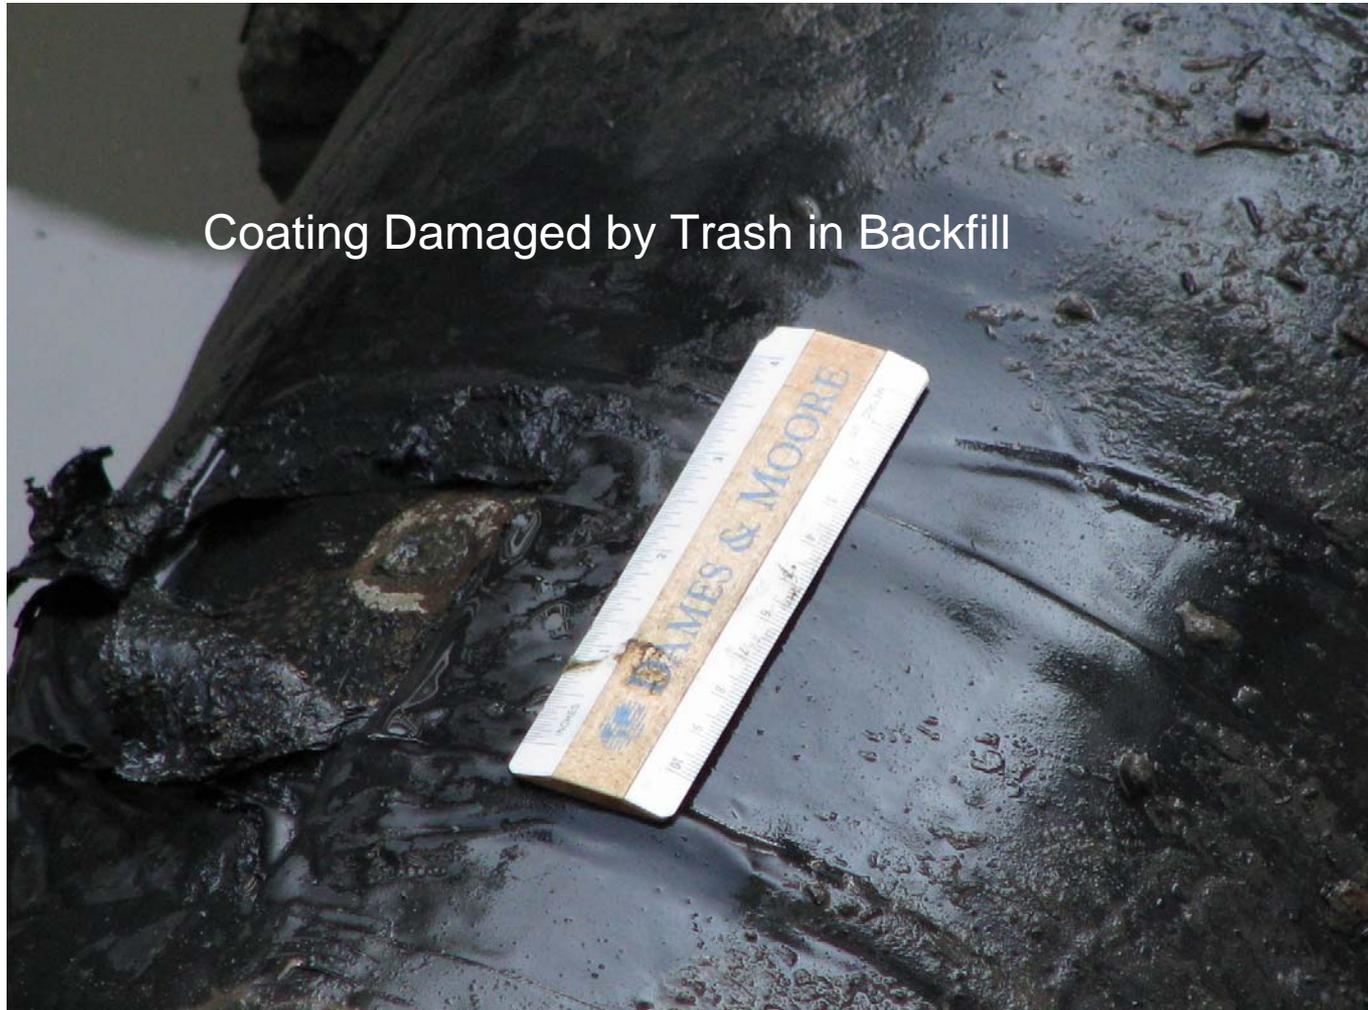
§192.303 - Failure to construct a main in accordance with comprehensive written specifications.

Coating Damaged by Trash in Backfill

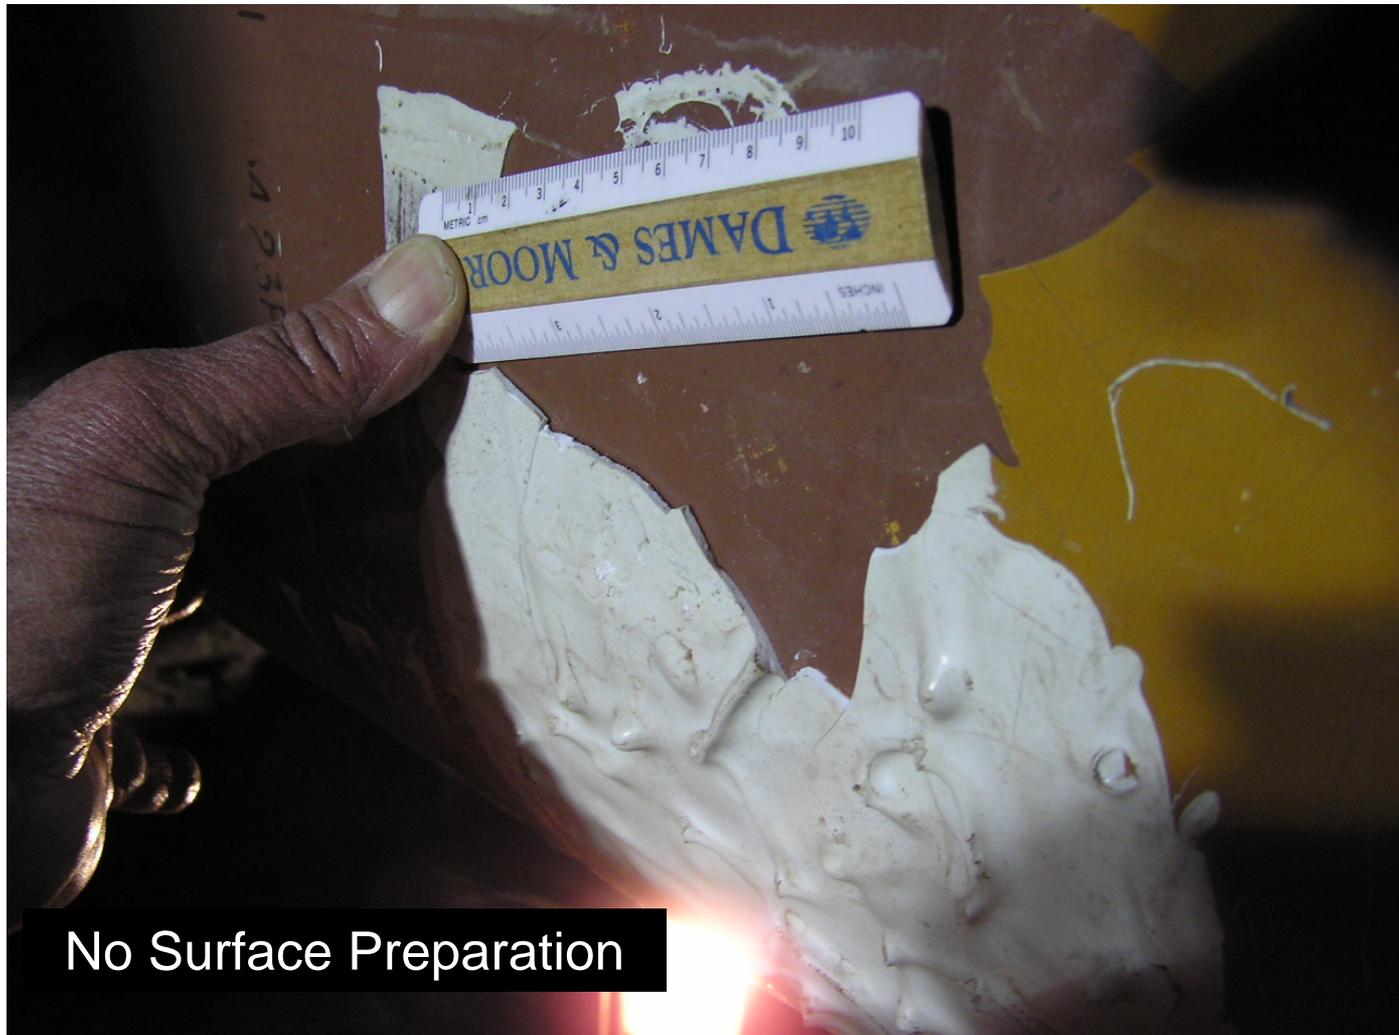
§192.303 - Failure to construct a main in accordance with comprehensive written specifications.

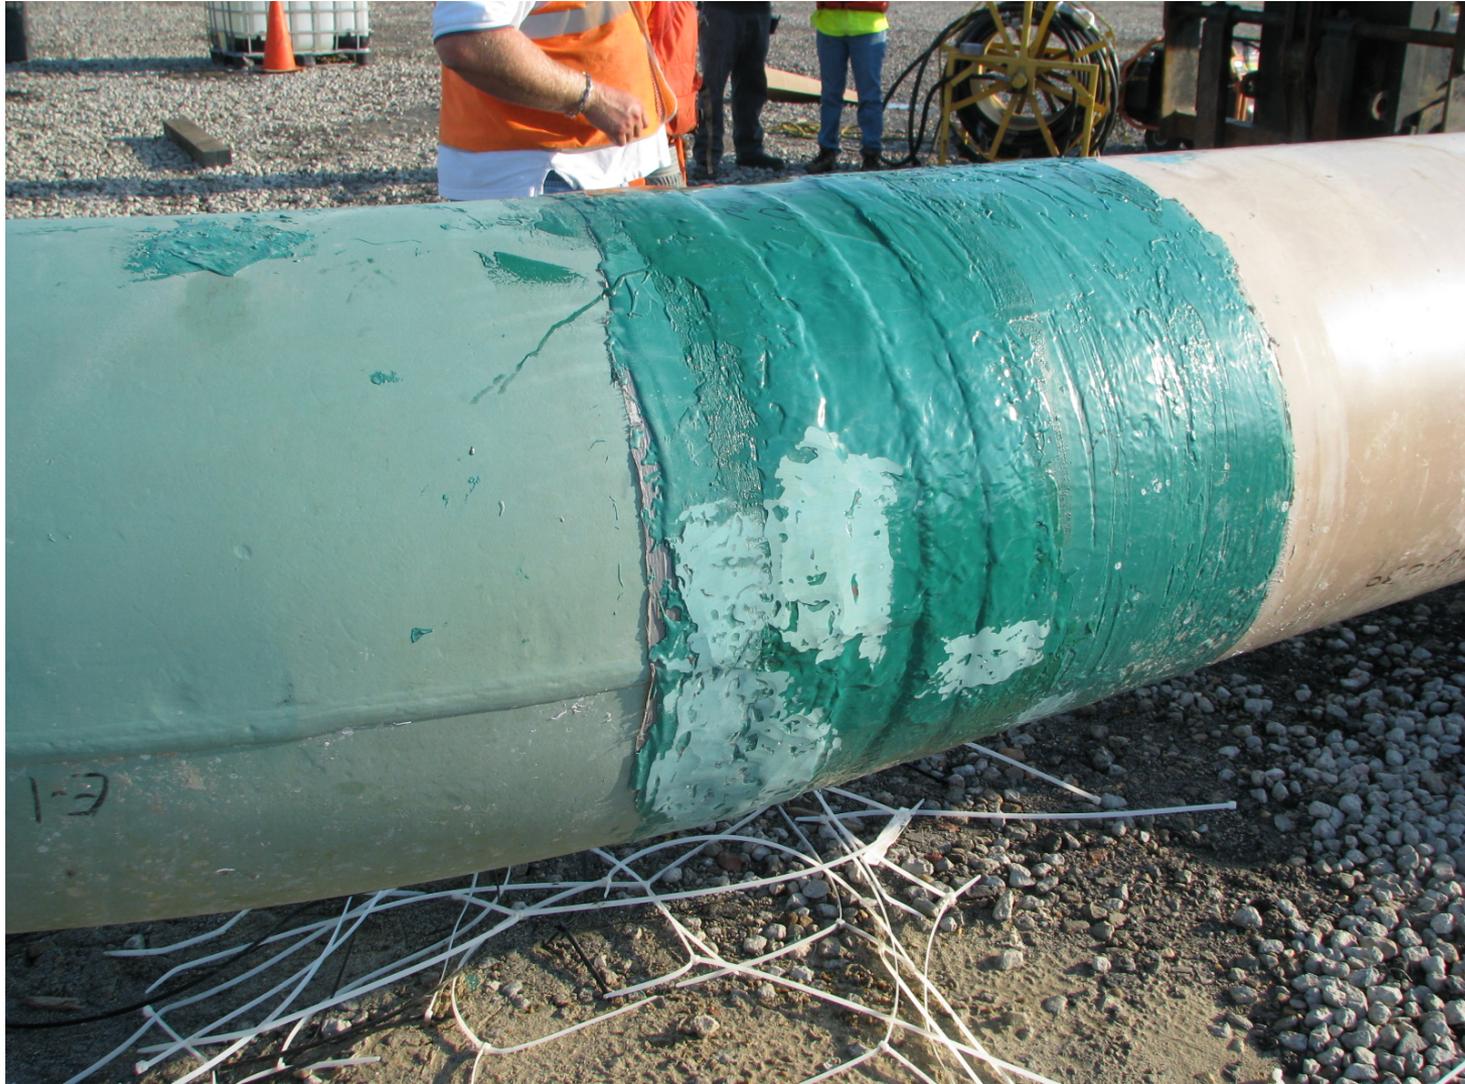
§192.303 - Failure to construct a main in accordance with comprehensive written specifications.

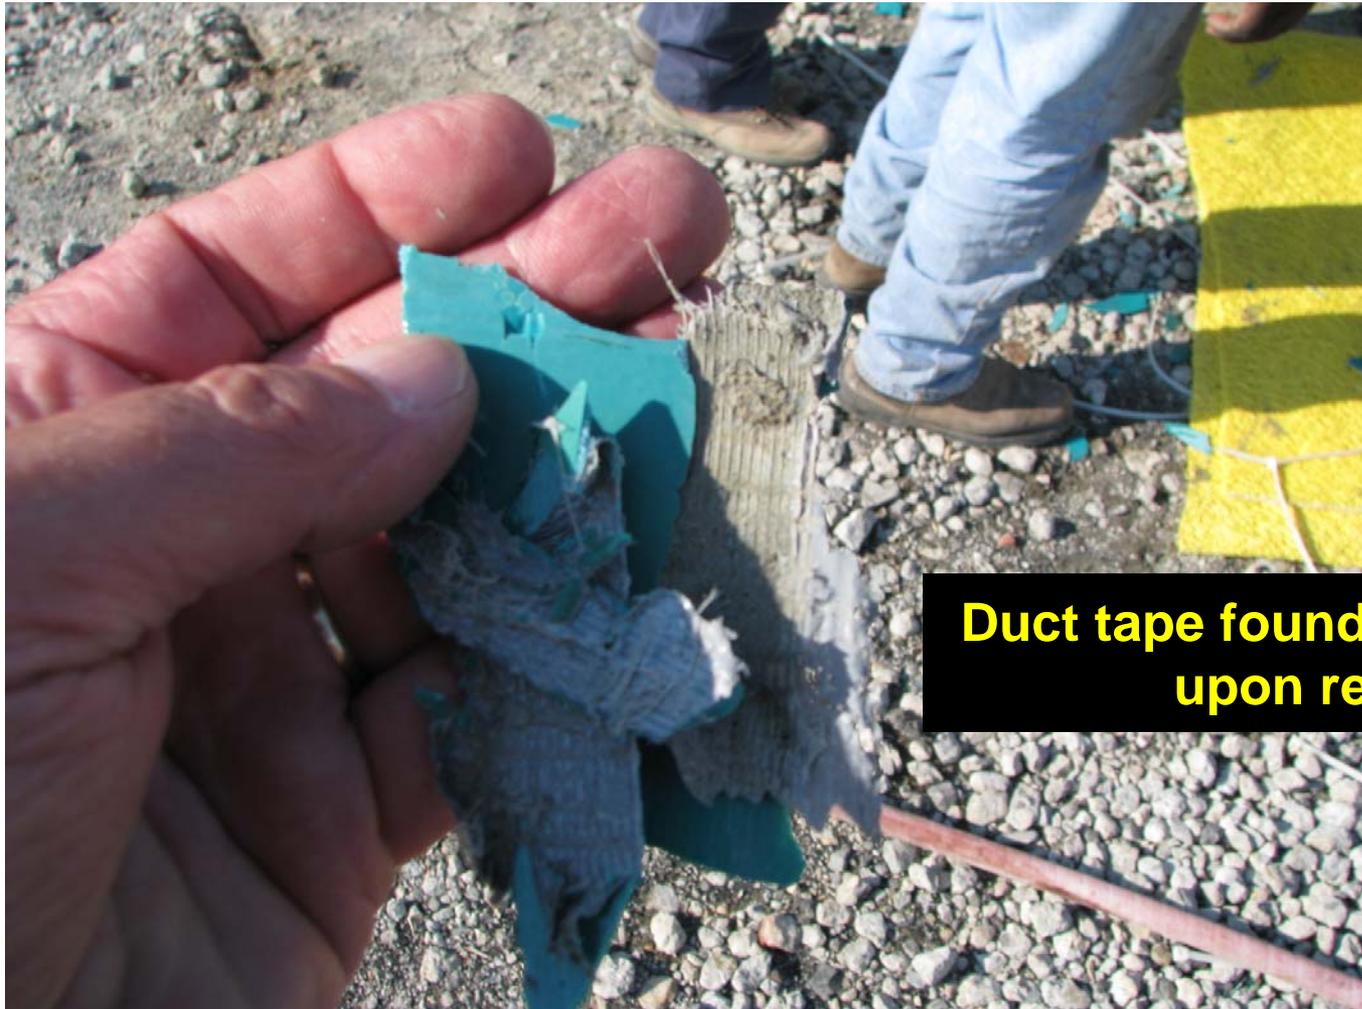
§192.303 - Failure to construct a main in accordance with comprehensive written specifications.

**Duct tape found under coating upon removal**

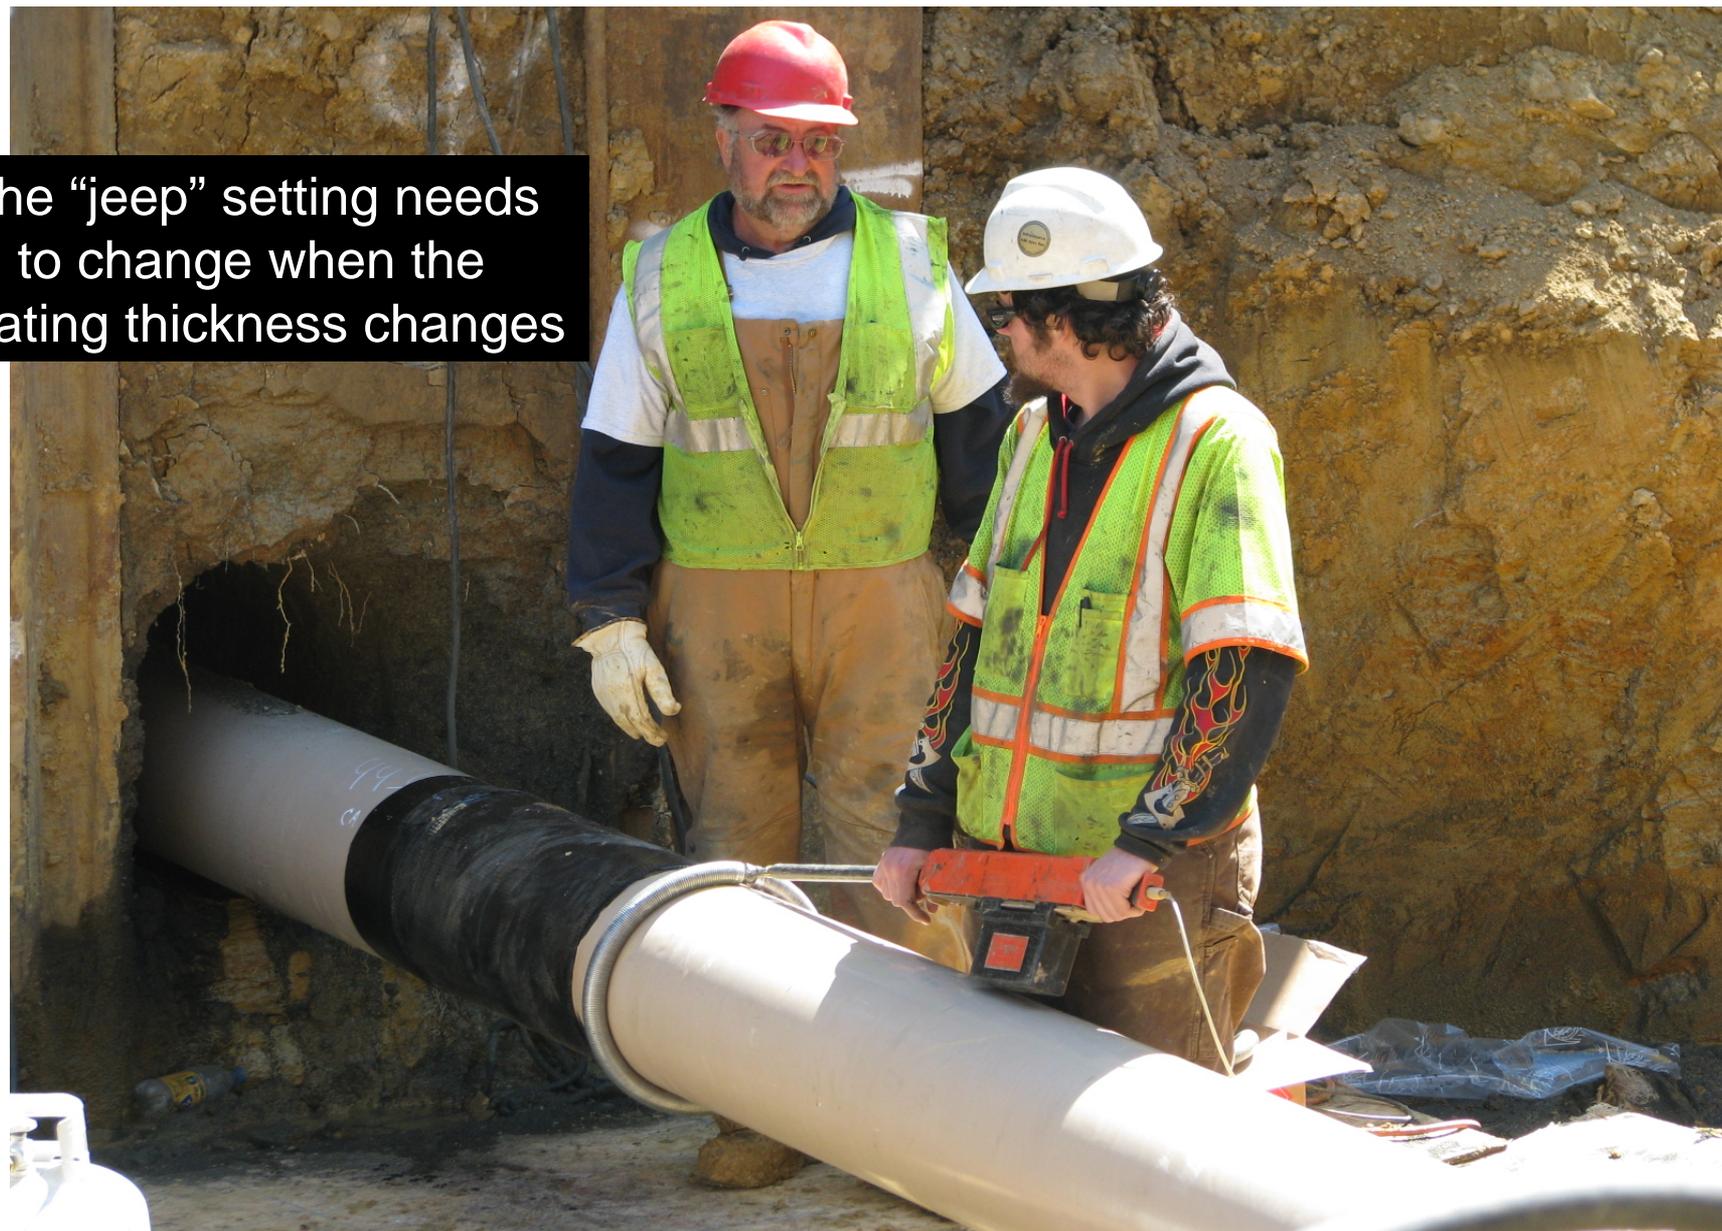
The “jeep” setting needs to change when the coating thickness changes
