# Virginia

## 2008 Inspection Activities

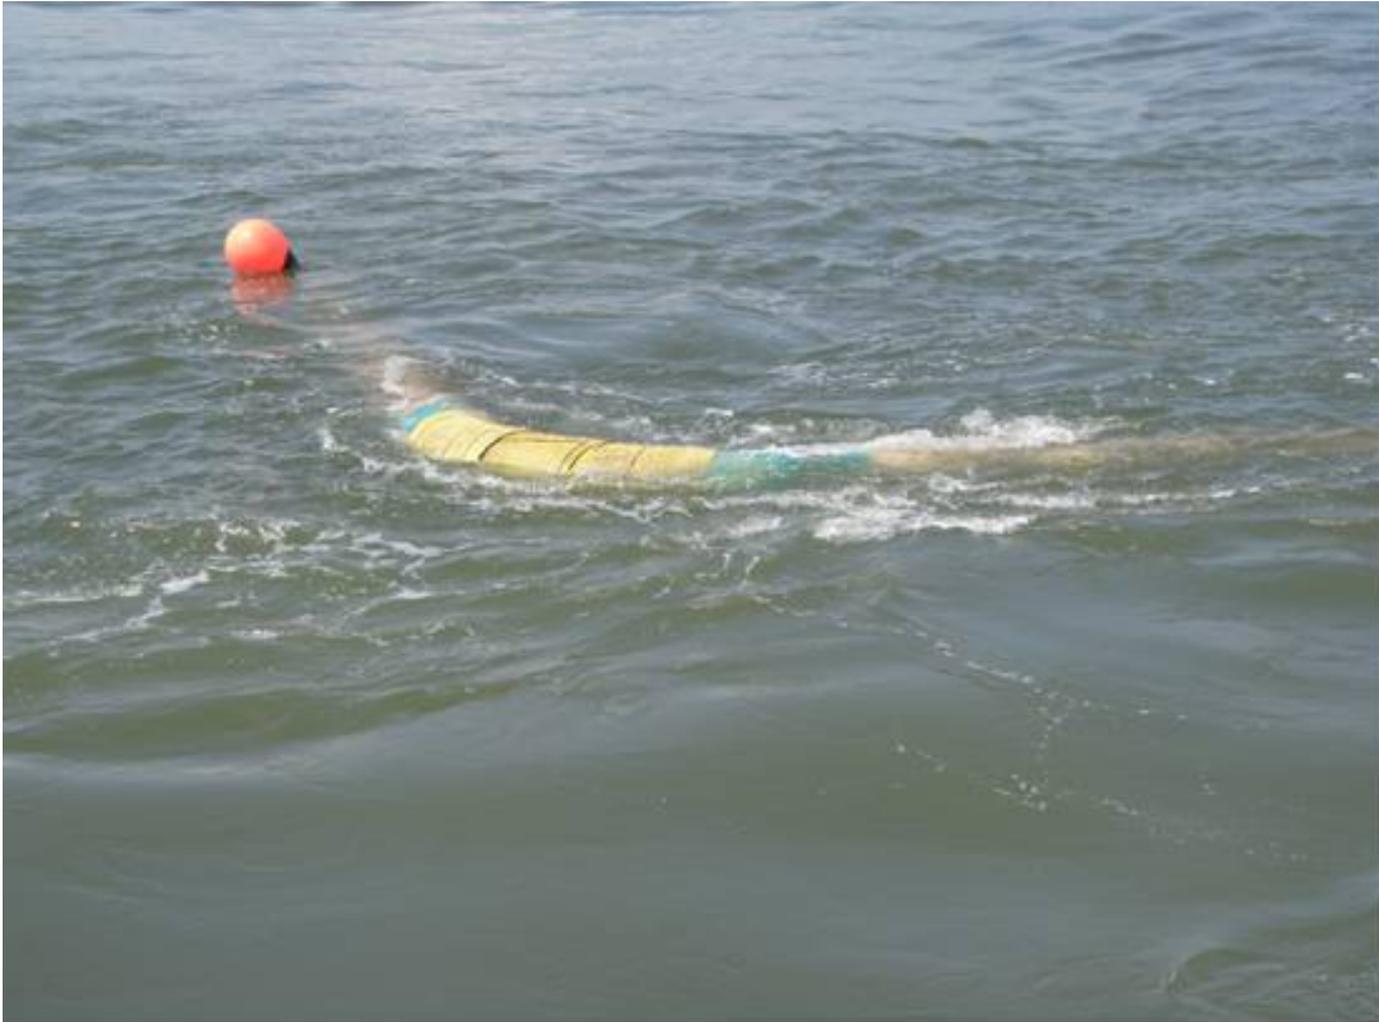
§192.303 - Failure to construct a main in accordance with comprehensive written specifications.

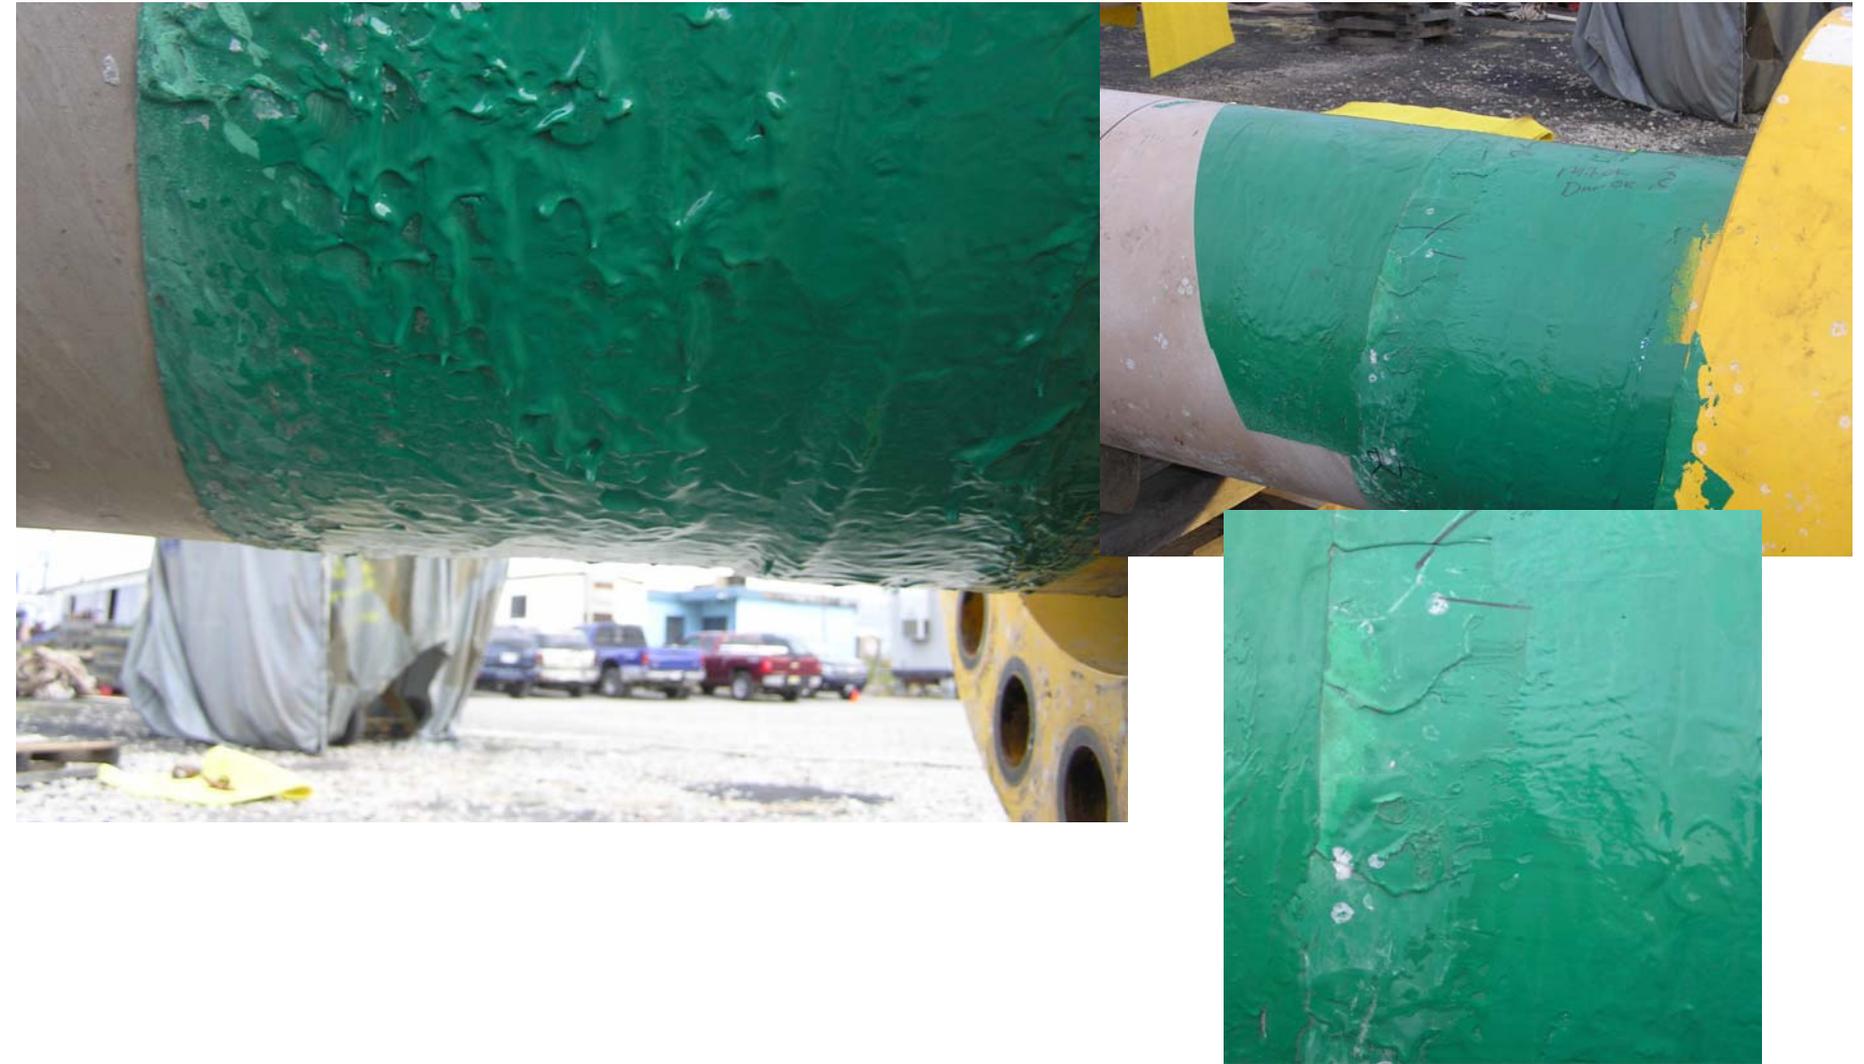
§192.303 - Failure to construct a main in accordance with comprehensive written specifications.

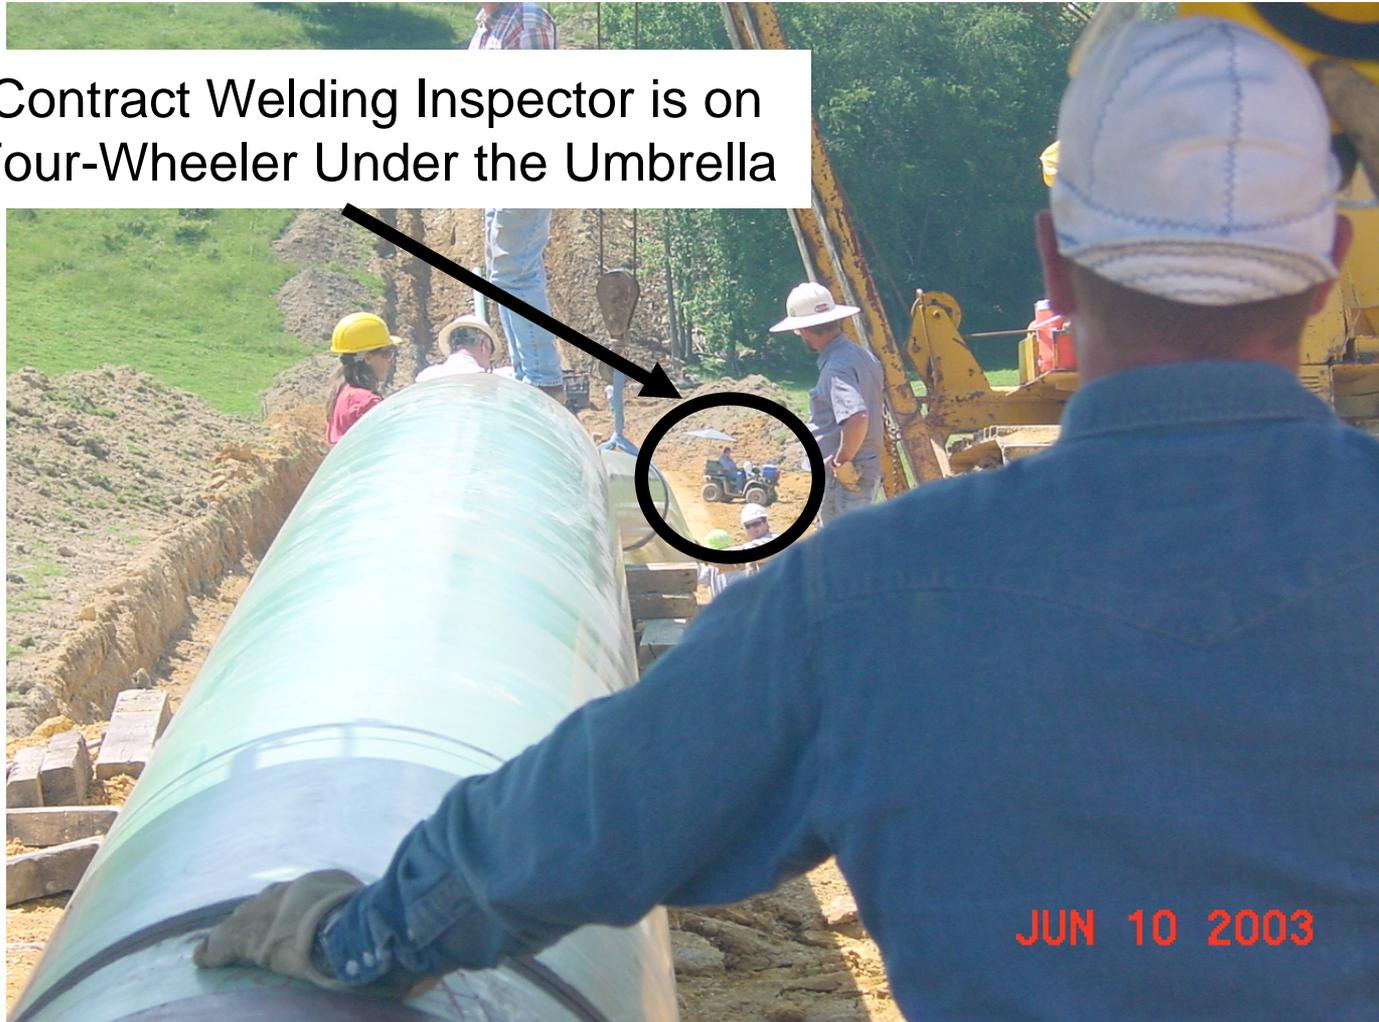
§192.303 - Failure to construct a main in accordance with comprehensive written specifications.

The Contract Welding Inspector is on the Four-Wheeler Under the Umbrella

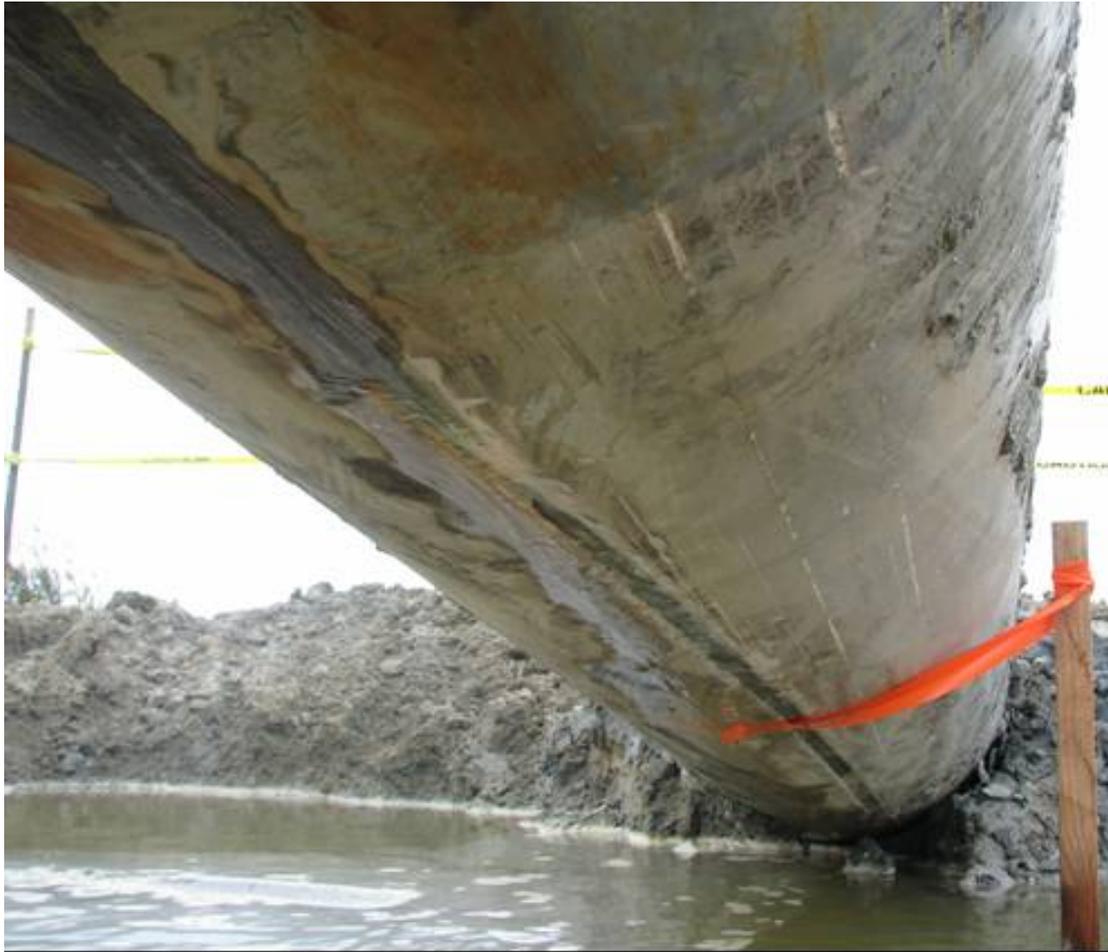
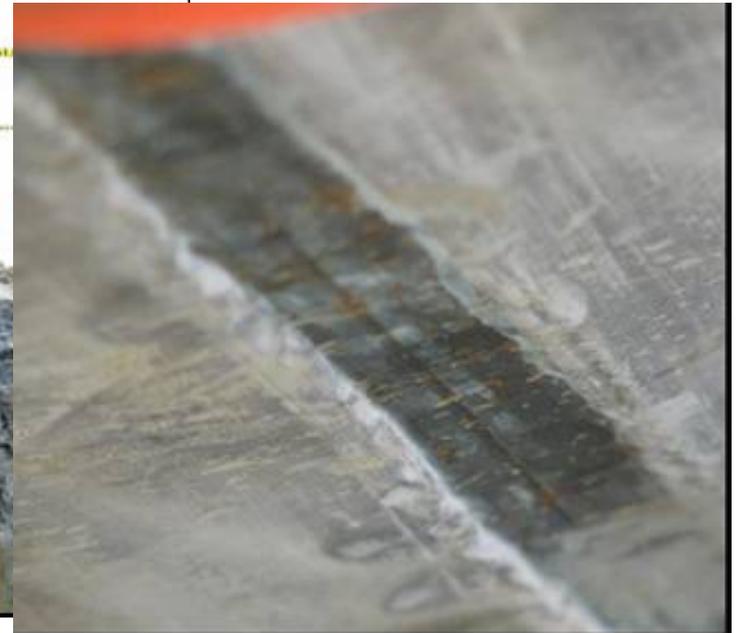
§192.303 - Failure to construct a main in accordance with comprehensive written specifications.
