DOT US Department of Transportation
PHMSA Pipeline and Hazardous Materials Safety Administration
OPS Office of Pipeline Safety
Eastern Region

Principal Investigators Girija S. Bajpayee and David A. Hippchen
Region Director Byron E. Coy
Date of Report 7/26/2011
Subject Failure Investigation Report – Columbia Gas Transmission – Adaline Compressor Station Fire

Failure Investigation Report – Columbia Gas Transmission – Adaline Compressor Station Fire

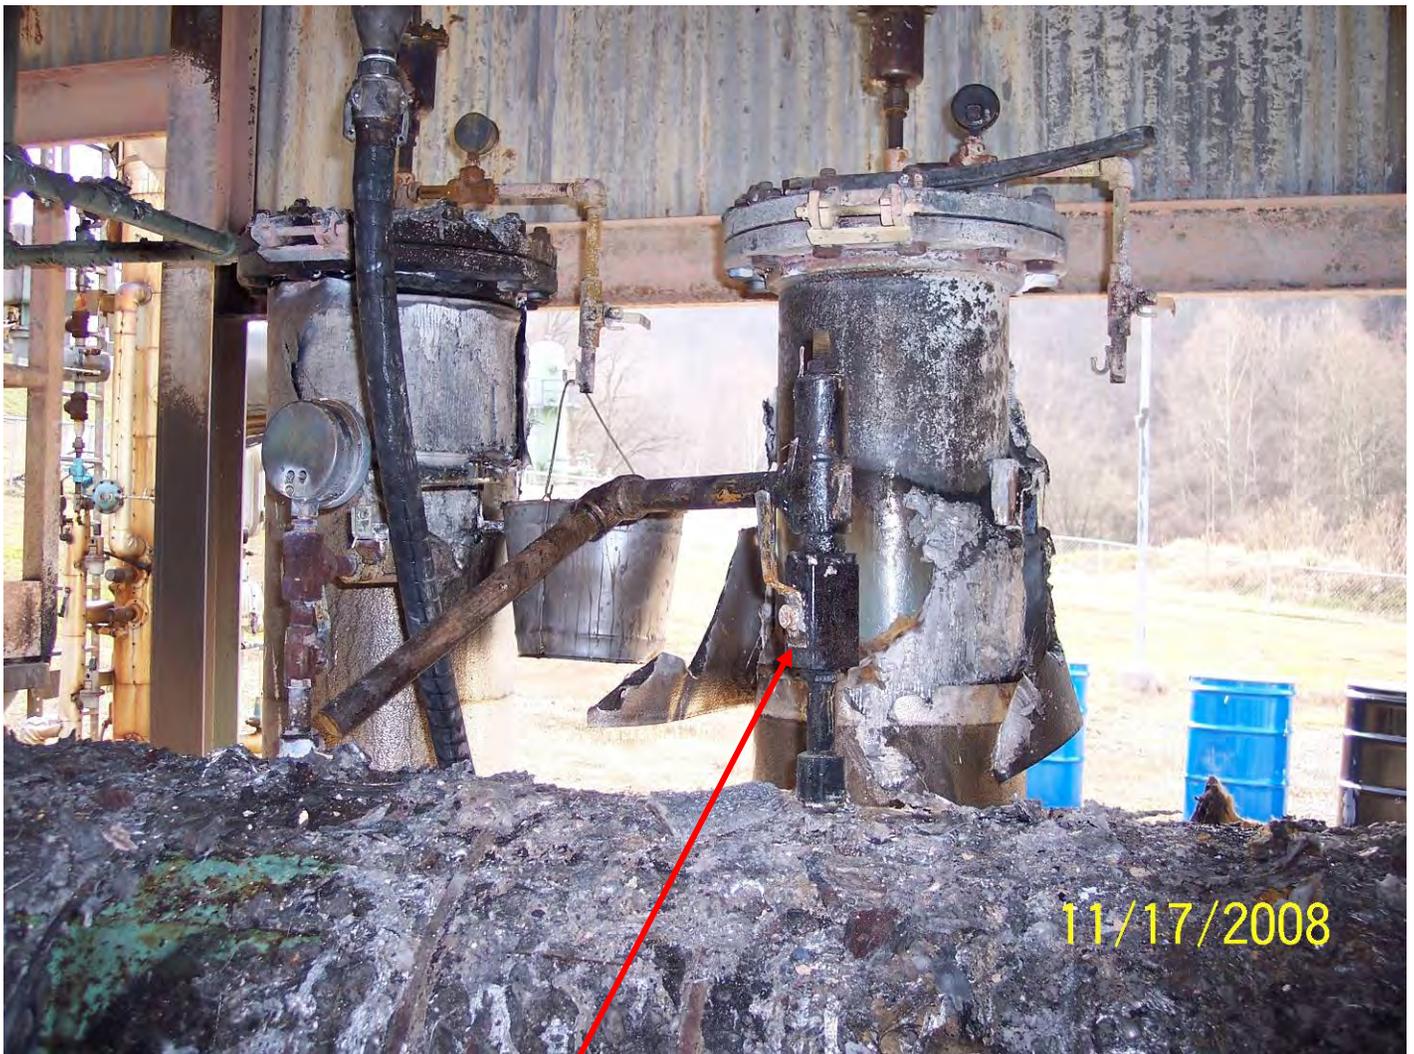
Photograph number -1

Location of the photograph – the structure that housed the integrated dehydration units of the Adaline compressor station.

This photograph reveals – the relief valve of the dehydration unit #1 through which the liquid and the flammable gas came out and consequently caused the fire and explosion.

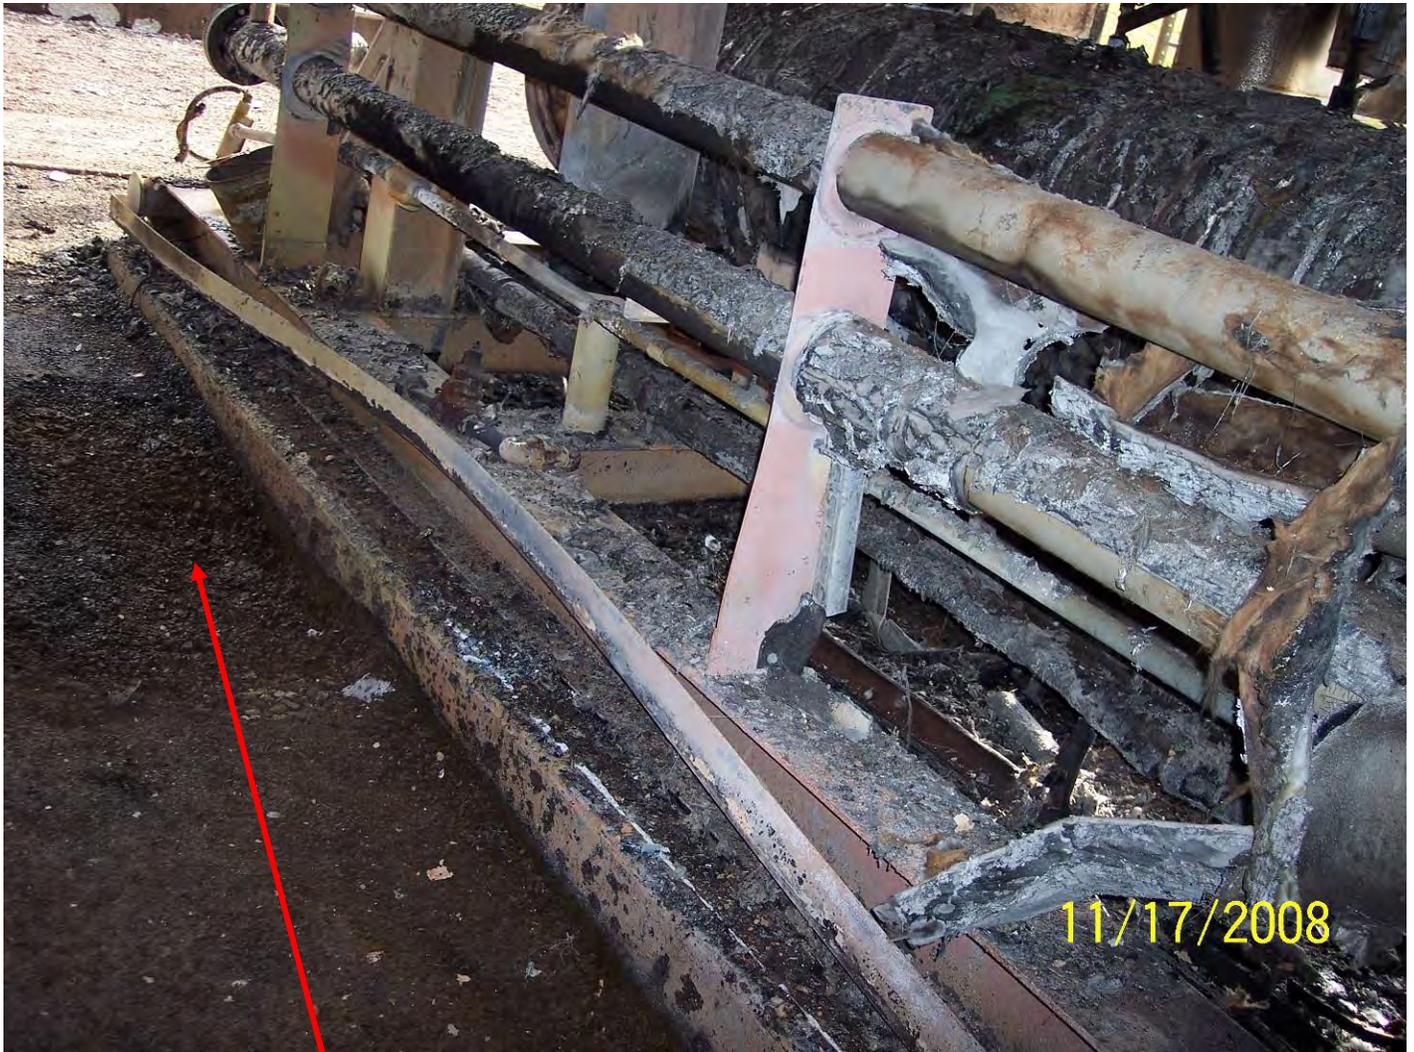
Photograph number -2

This photograph reveals – the pit caused by the thrust of the gas & liquid that came out through the relief valve of the dehydration unit #1.

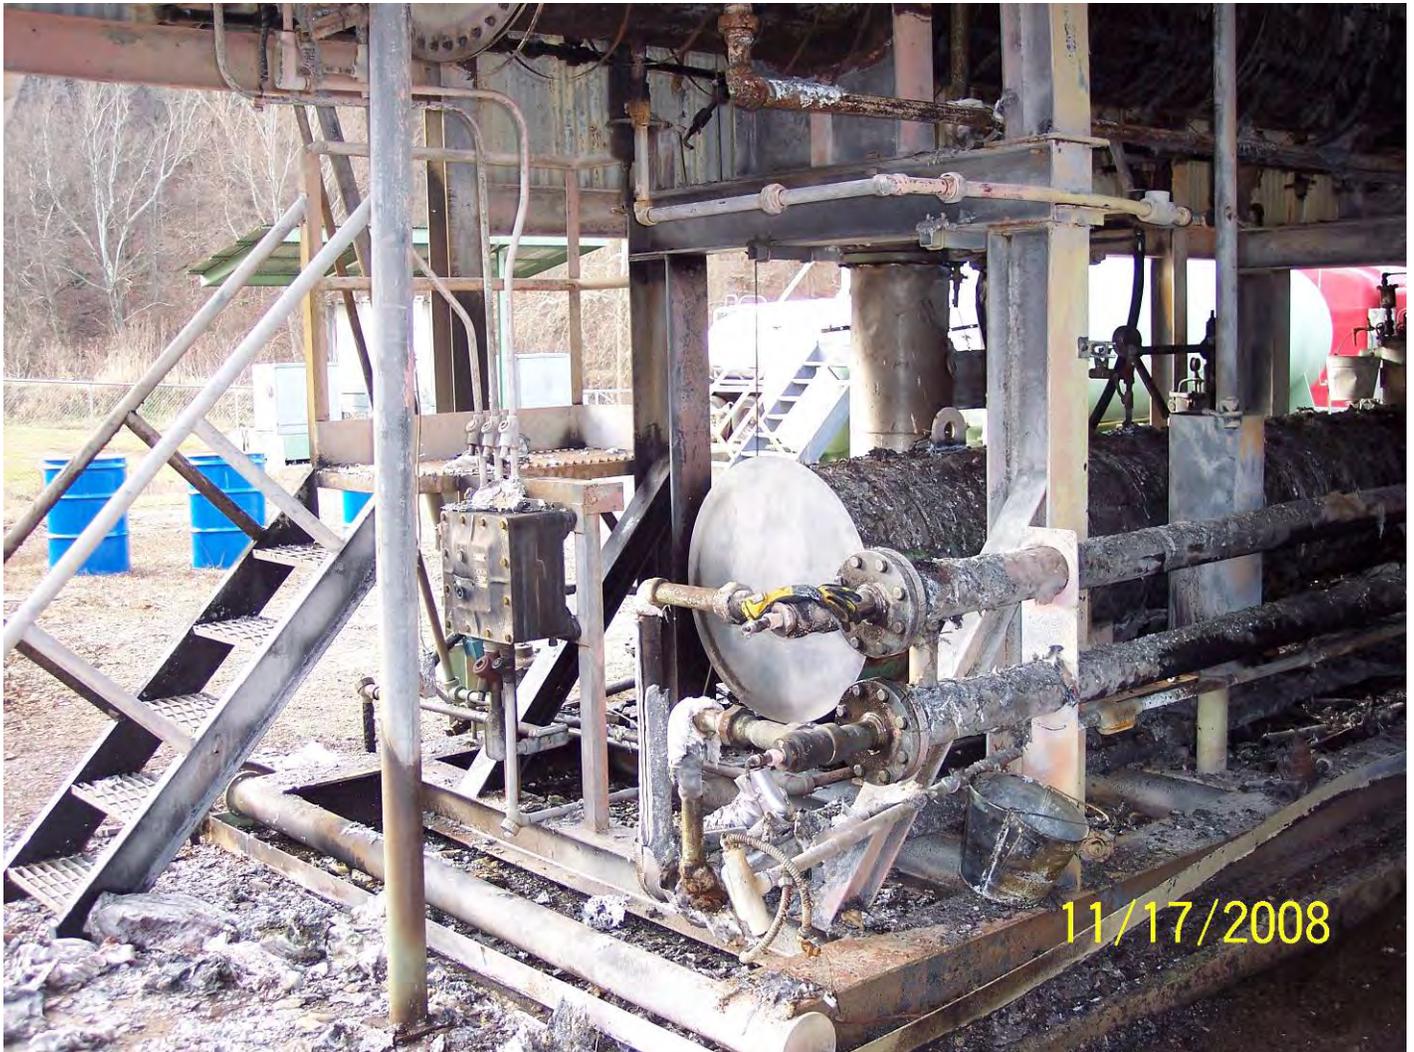
Photograph number -3

This photograph reveals – the damage of the dehydration unit #1, caused by the fire & explosion.

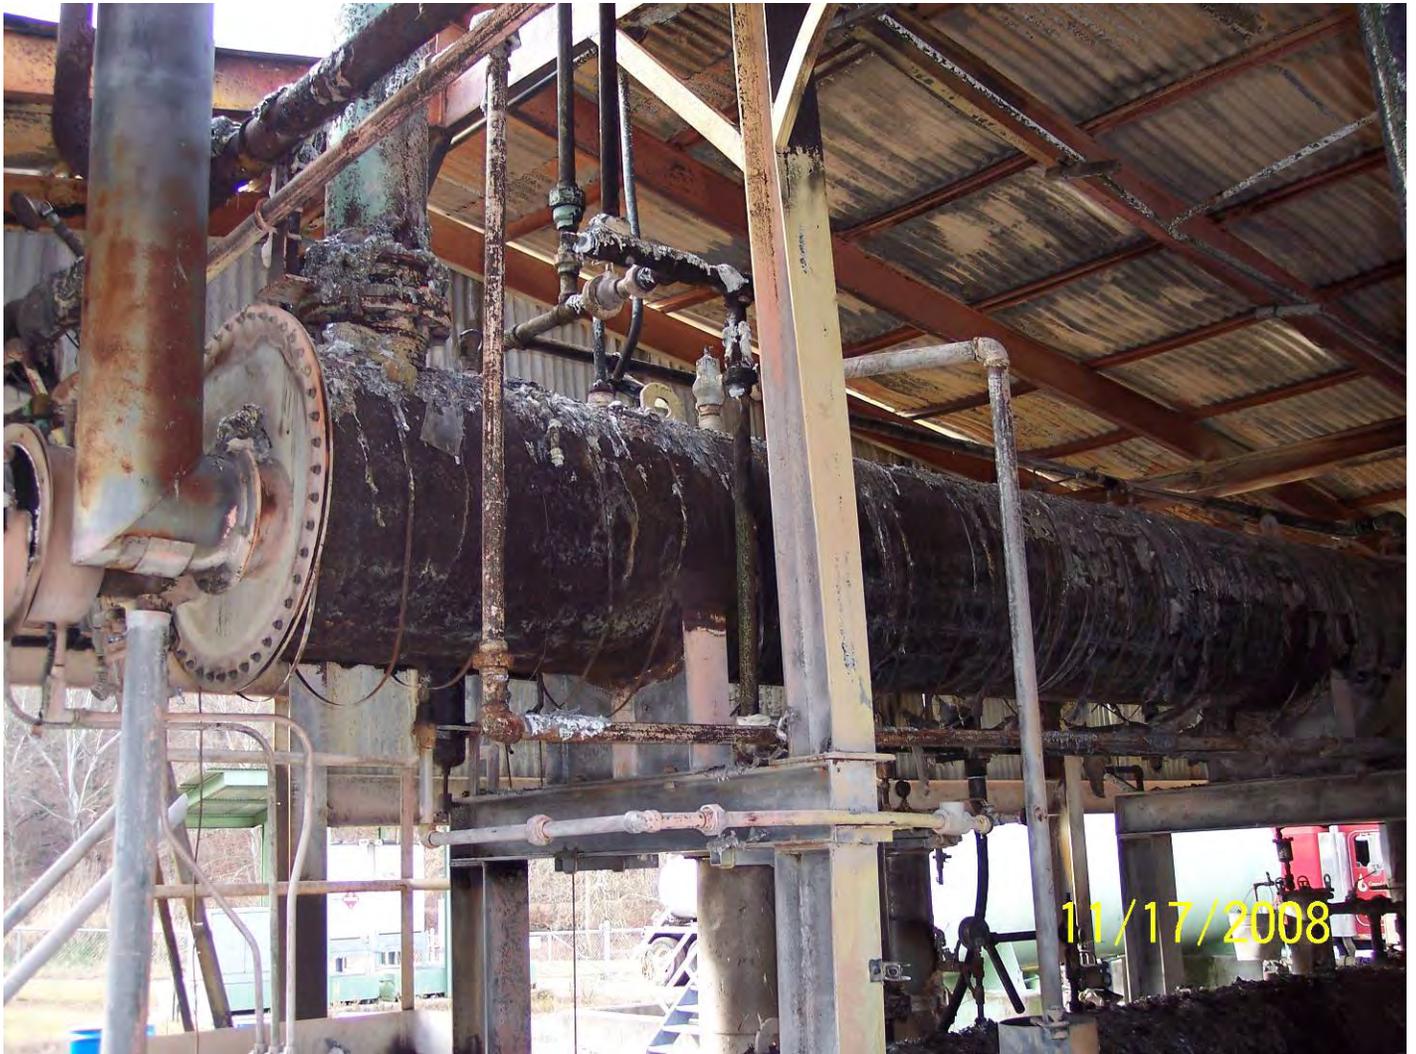
Photograph number -4

This photograph reveals – the damage of the dehydration unit #2, caused by the fire & explosion.

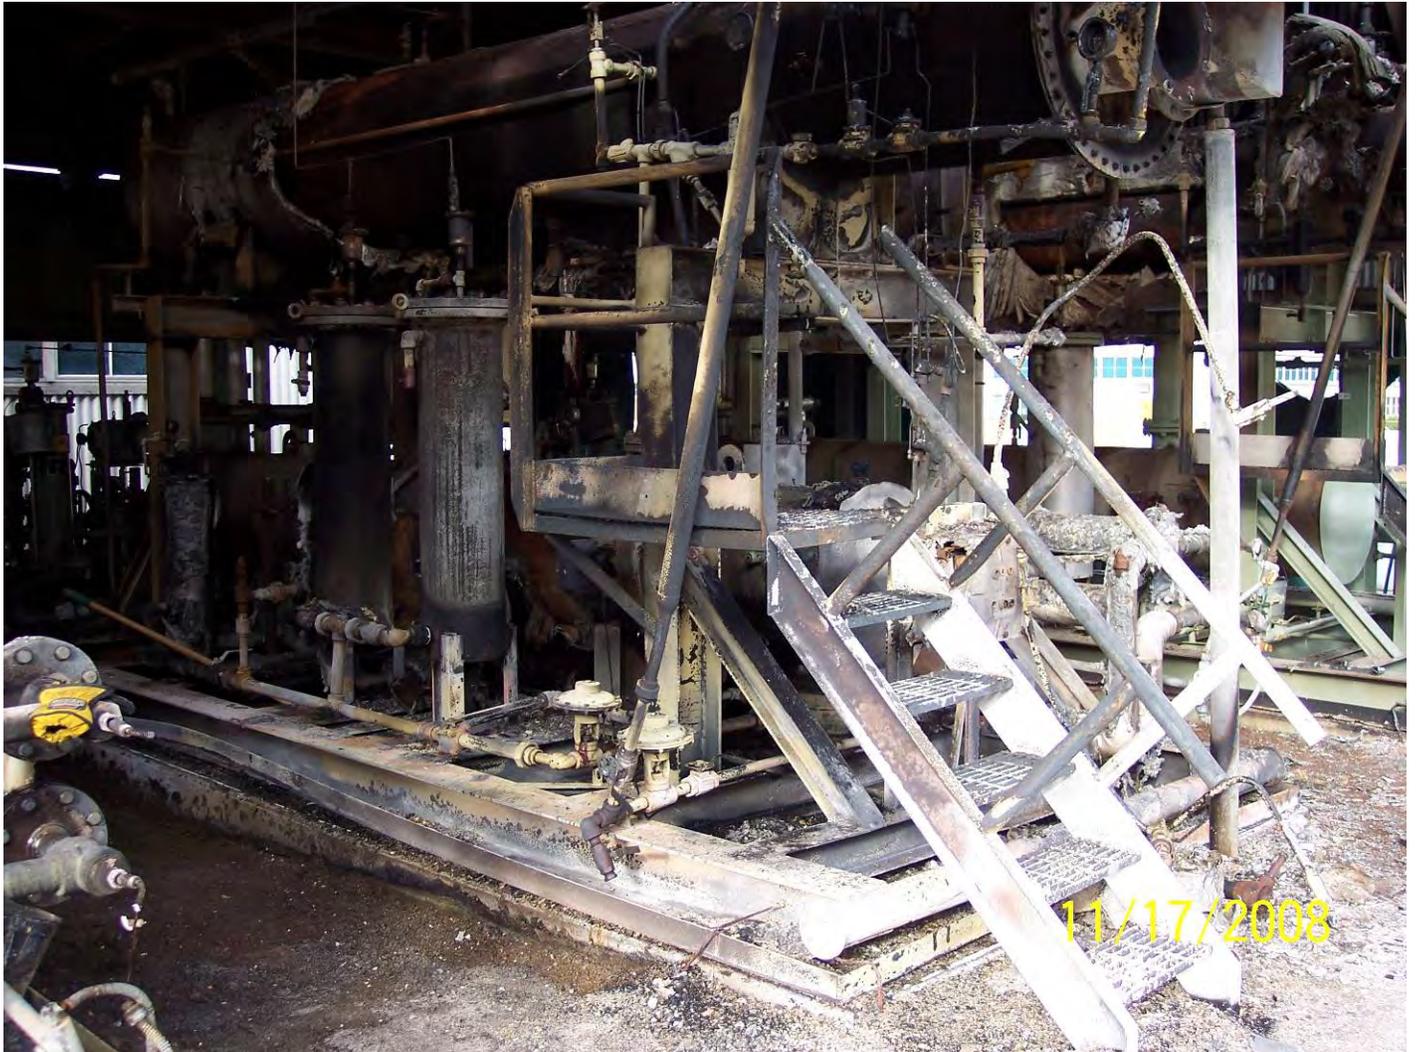
Photograph number -5

This photograph reveals – the damage of the dehydration unit #2, caused by the fire & explosion.

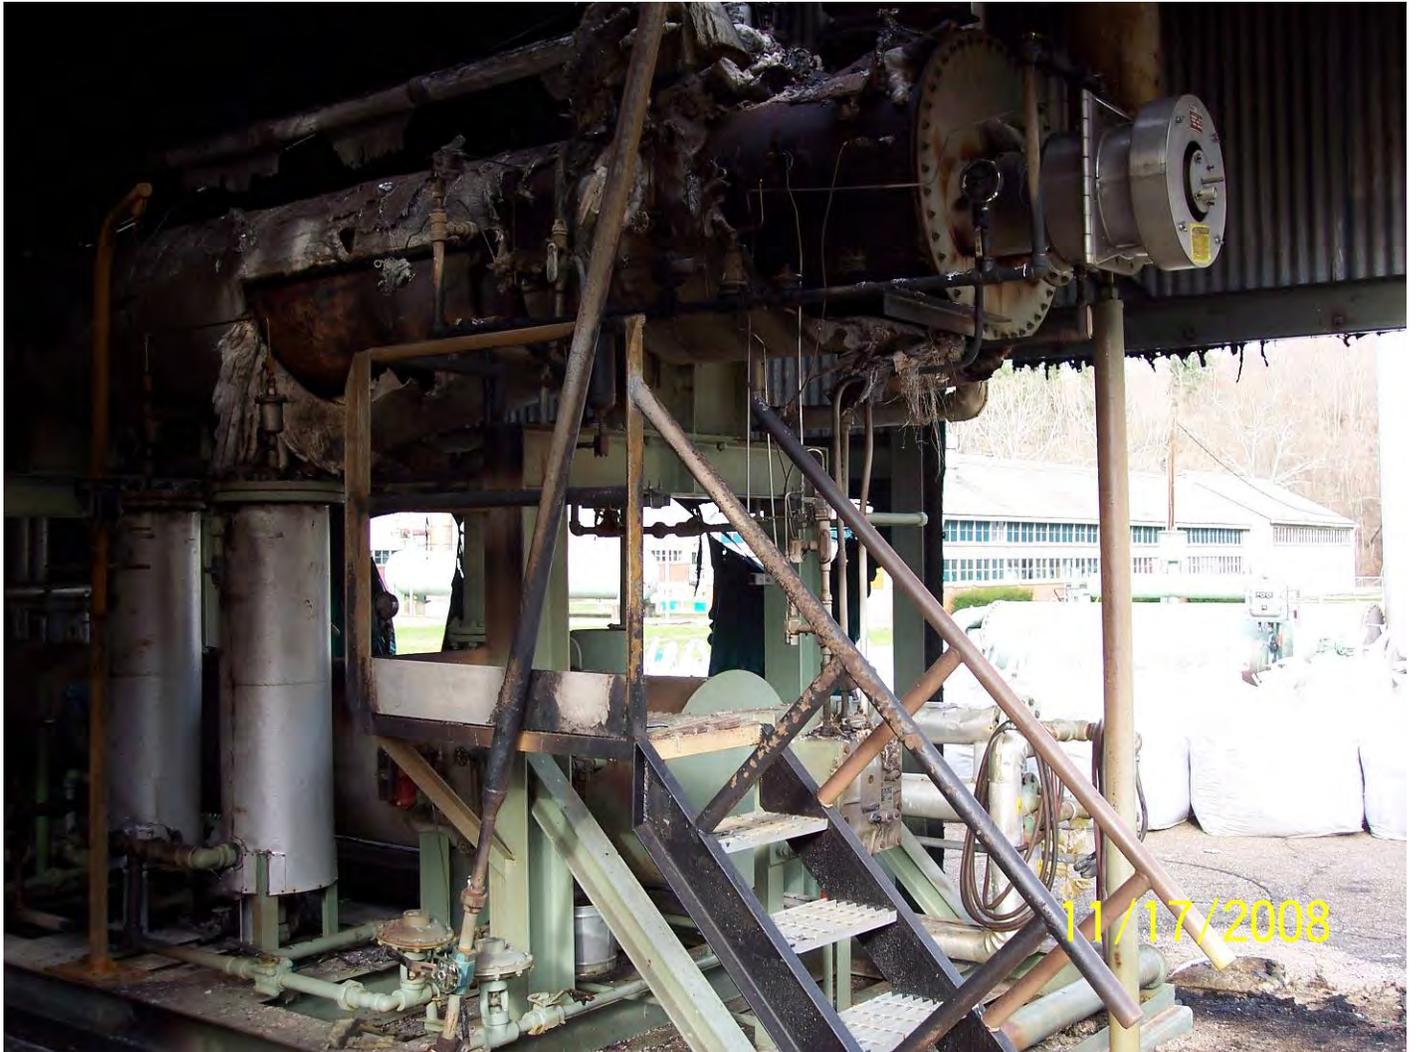
Photograph number -6

This photograph reveals – the damage of the dehydration unit #3, caused by the fire & explosion.

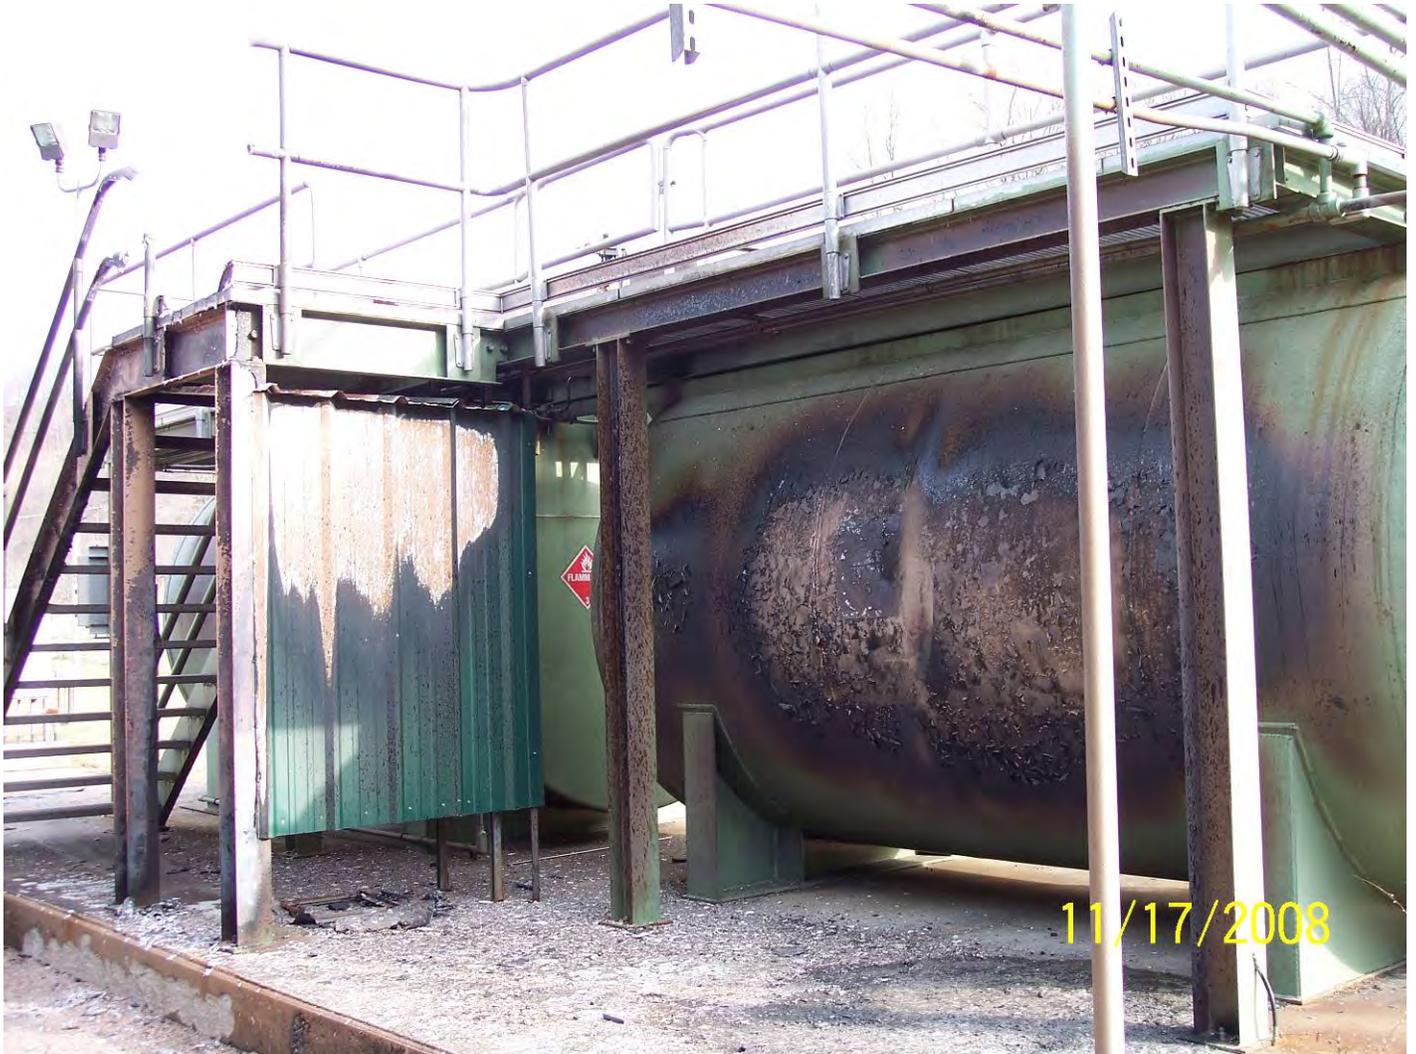
Photograph number -7

This photograph reveals – the damage to the nearby vessel due to the fire.

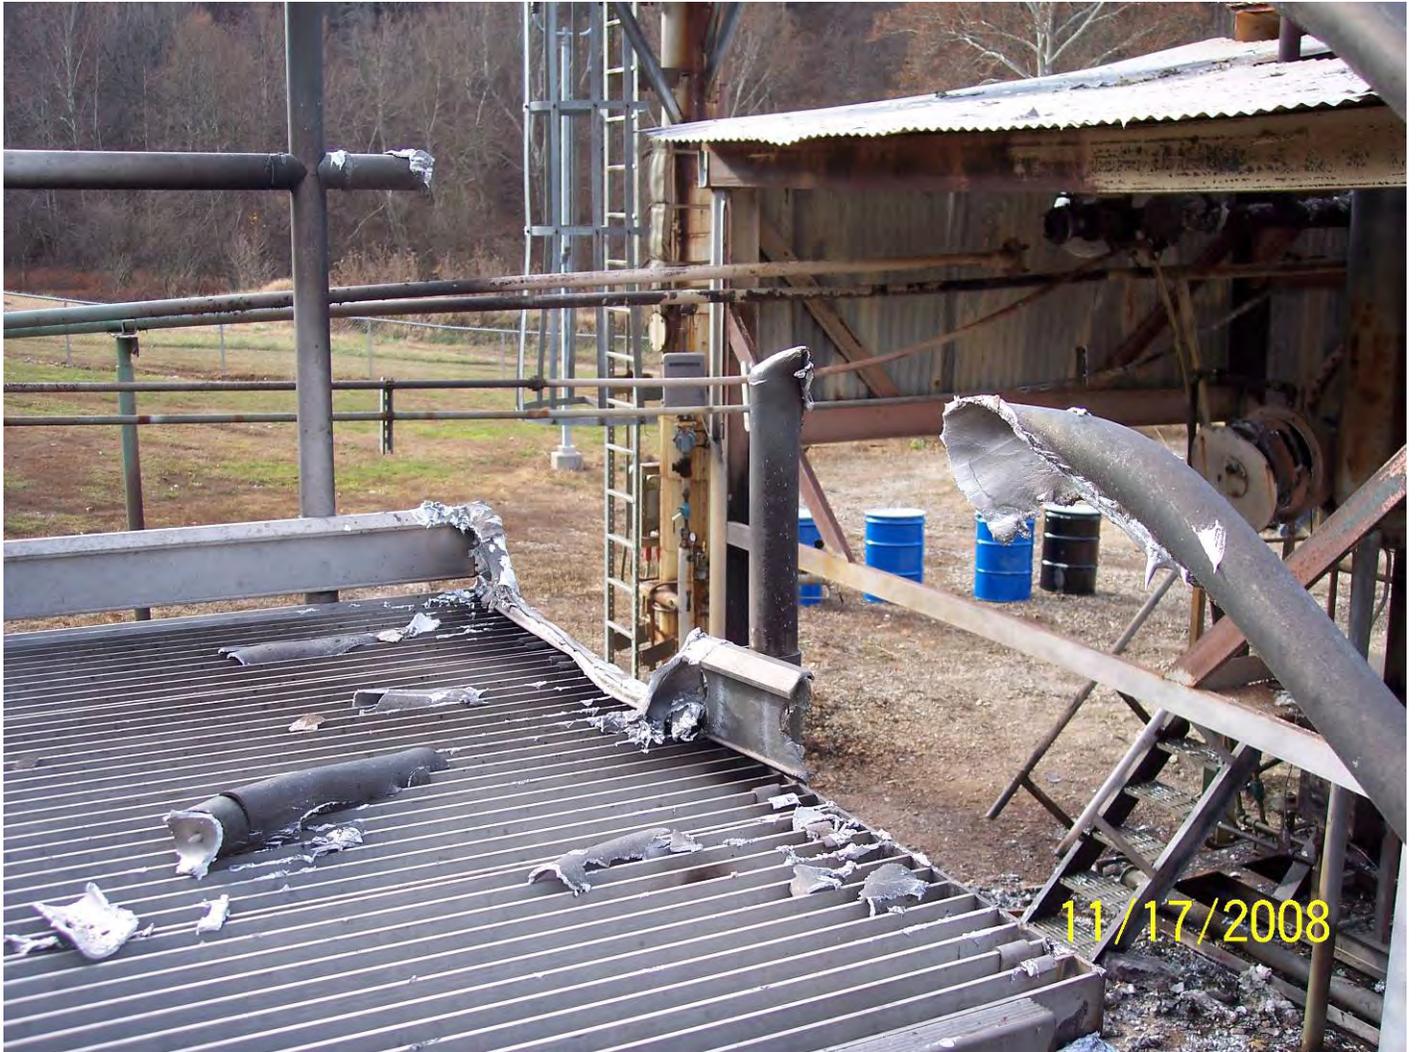
Photograph number - 8

This photograph reveals – the damage to the nearby structure due to the intensity of the fire (the metal of the fence even melted).

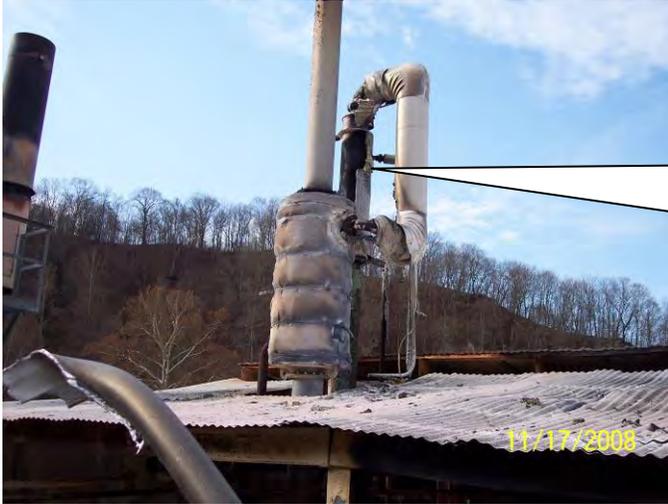
Photograph number - 9

The damage due to the fire to the portion of the dehydration unit #1, that existed above the structure.

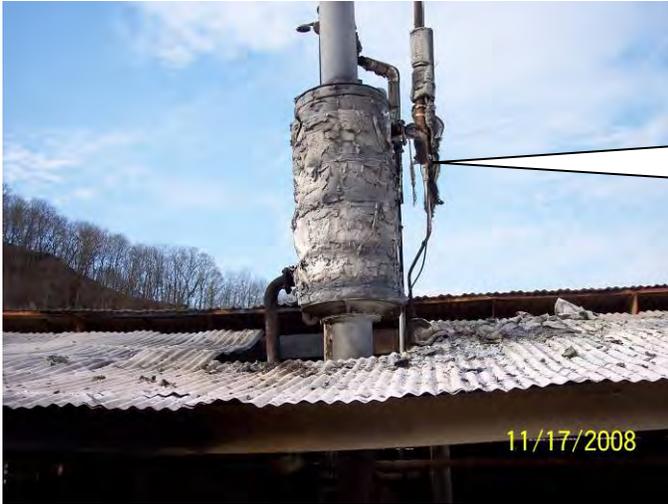
Photograph number - 10

The damage due to the fire to the portion of the dehydration unit #2, that existed above the structure.

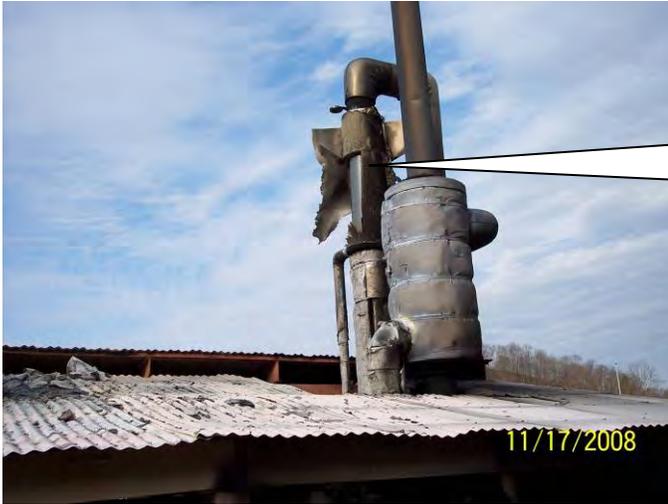
Photograph number - 11

The damage due to the fire to the portion of the dehydration unit #3, that existed above the structure.

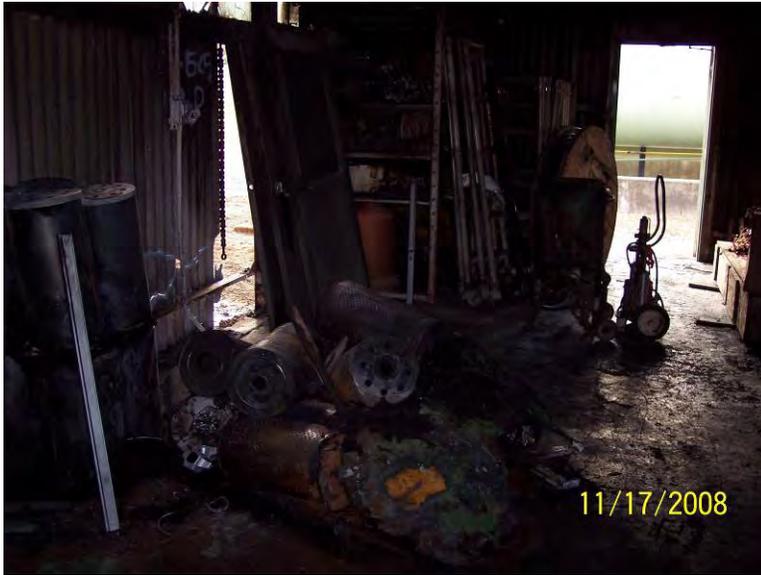
Photograph number -12

Fire damage to the items that existed inside the annexed structure

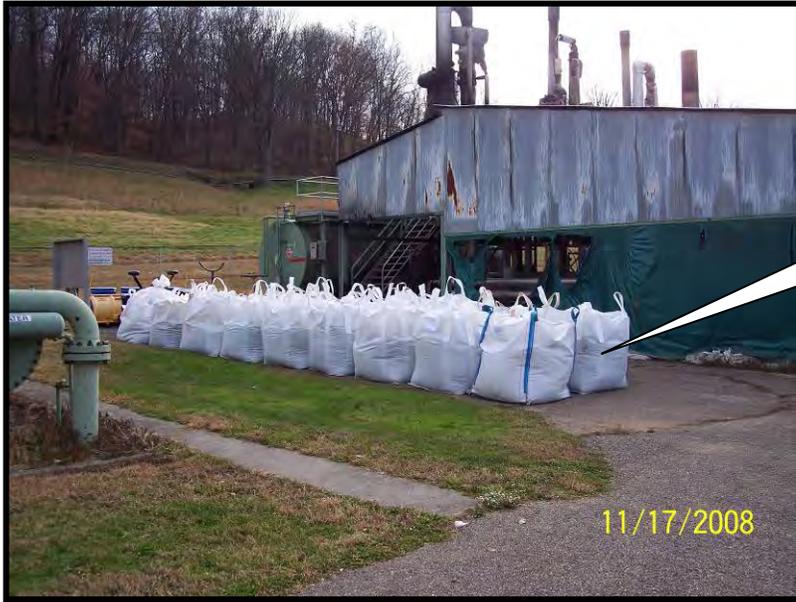
Photograph number - 13

The contaminated soil that was collected & placed within the plastic bags
