Principal Investigator Jeremy Kemak - NYSDPS
Senior Accident Investigator Michael Yazemboski - PHMSA ER
Region Director Byron E. Coy
Date of Report 10/29/2012
Subject Failure Investigation Report – Columbia Gas Transmission Millennium Pipeline Leak Owego, NY

Failure Investigation Report - Columbia Gas Transmission, Millennium Pipeline Weld Anomaly
Failure Date 01/11/2011

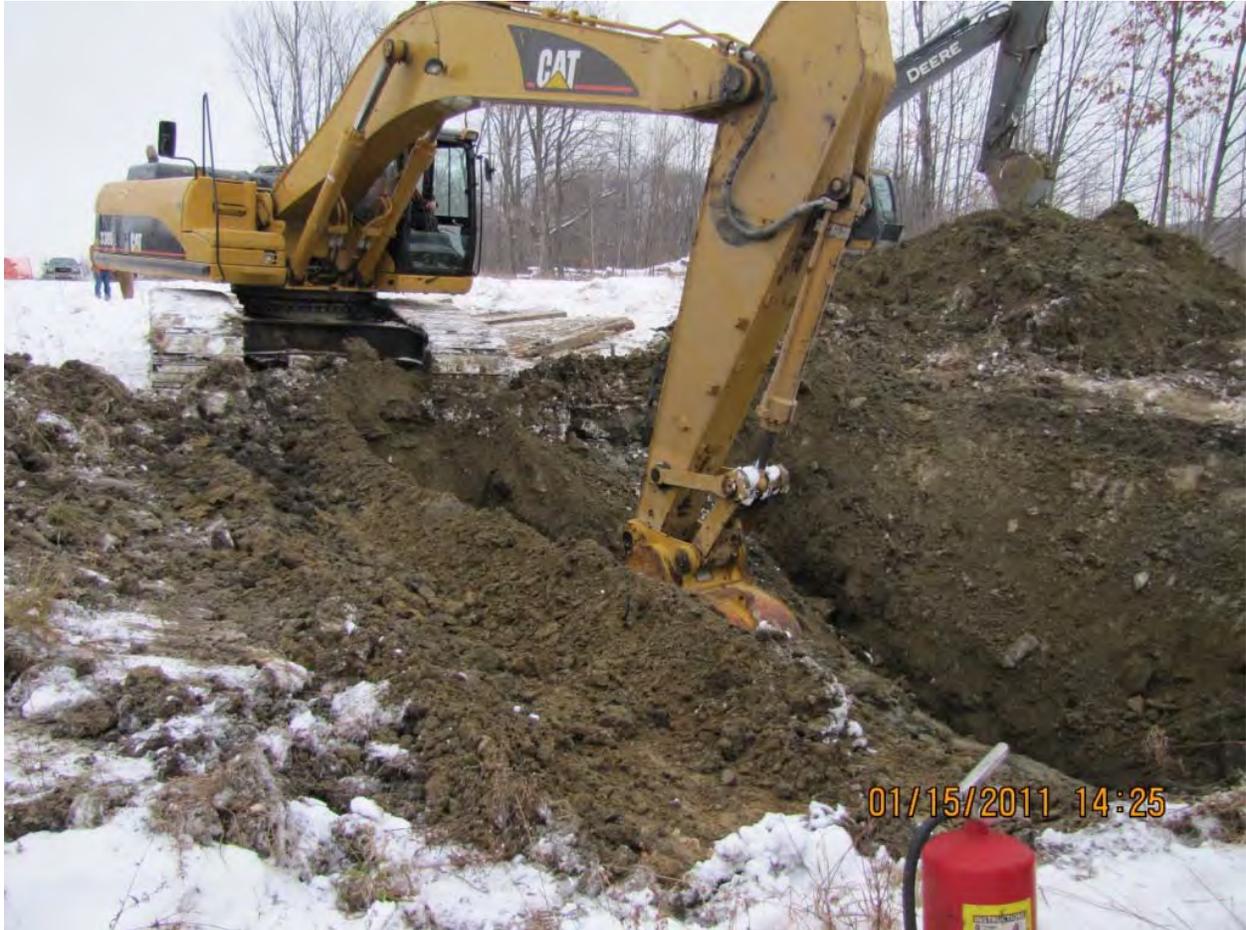
Excavation of leak site

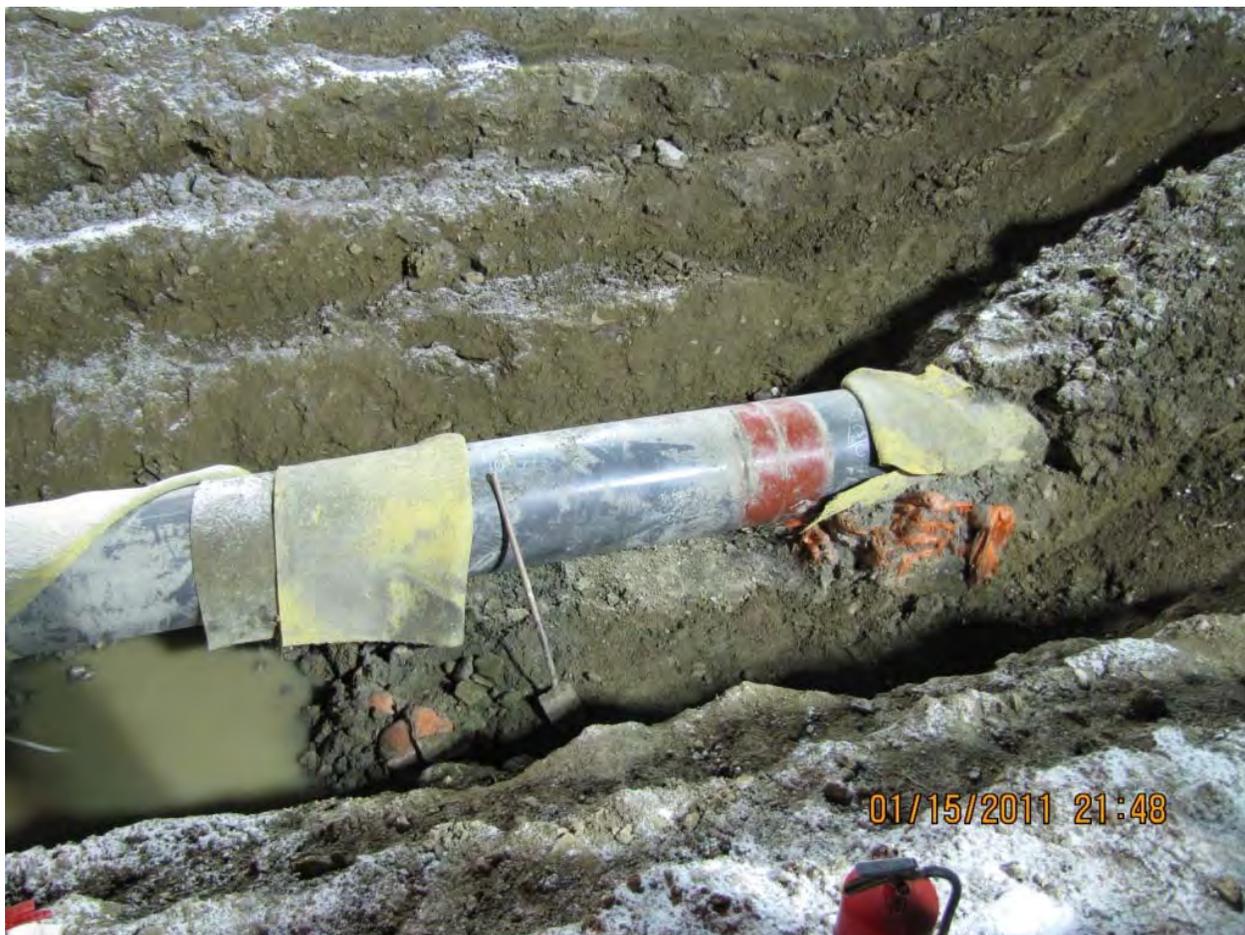
Exposed section containing double joint anomaly

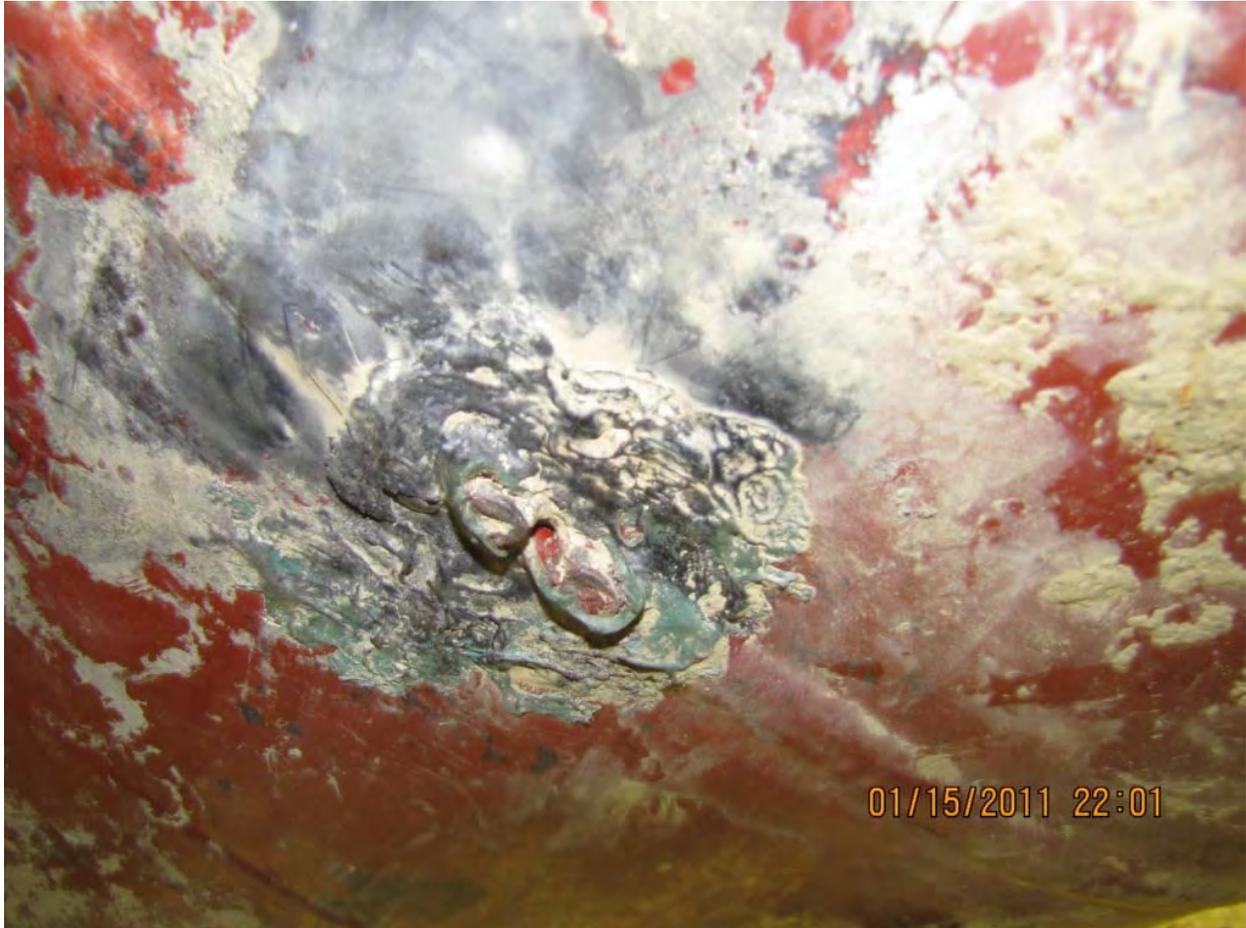
the leak was confined to the anomaly area. The weld anomaly measured approximately 0.125 inches in length and was located near the bottom of the pipe at the 5:30 o'clock position.

As a result of the investigation, it was determined that the leak was due to a circumferential weld defect on a double joint section of pipe. The weld defect, measuring approximately 0.125 inches in length, was located near the bottom of the pipe at the 5:30 o'clock position (Appendix B). A review of the

Anomaly as found

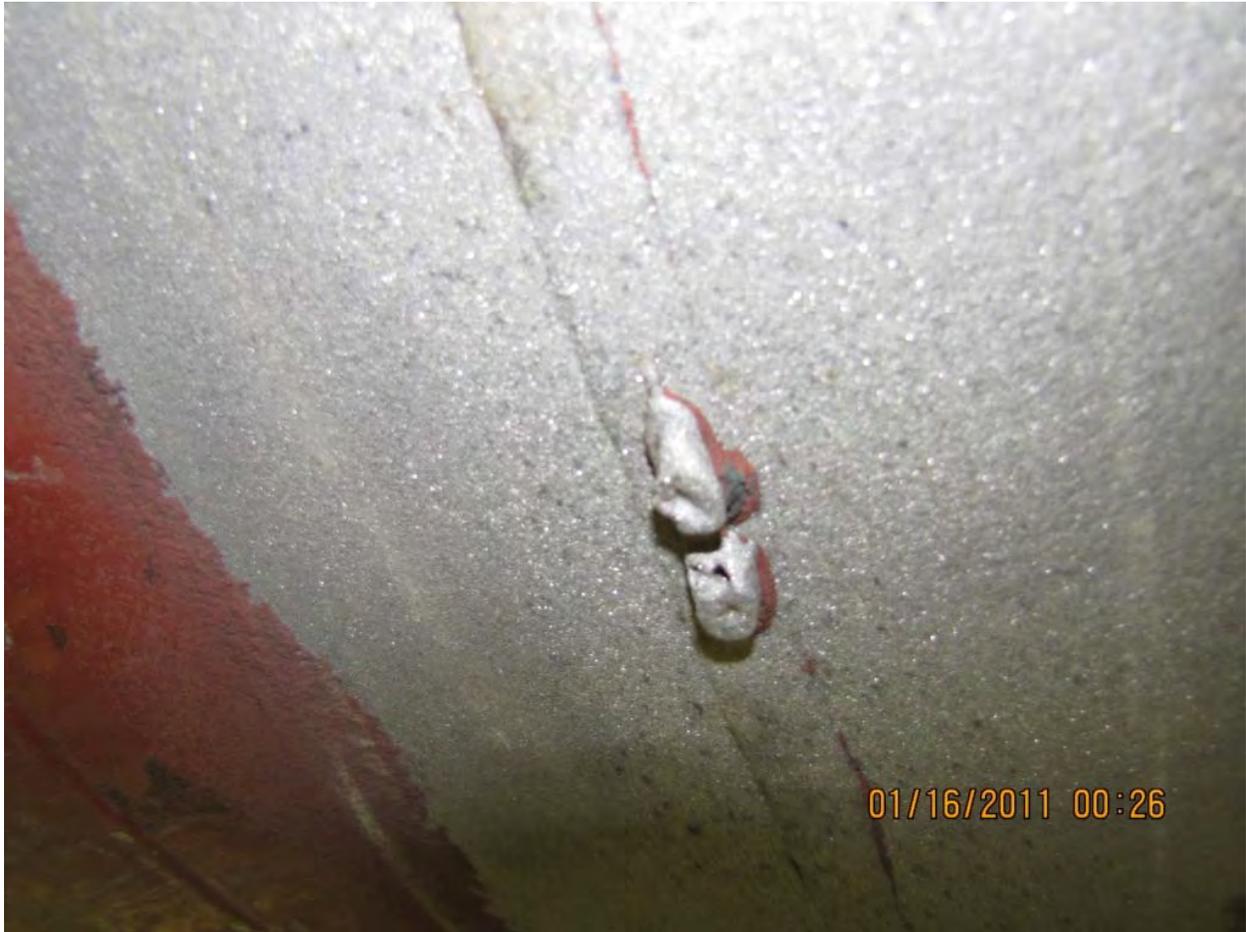
Anomaly after being sandblasted

In order to permanently repair the leak, excess material was removed from anomaly area, the weld was manually re-welded, and a 3/8 inch thick Dresser Style 115 welded repair sleeve was installed (Appendix B). The repair sleeve was non-destructively evaluated through magnetic particle inspection, and the repair of the leak was completed at 11:30 on January 16, 2011. Once coating was complete, proper backfill was reestablished, and the pipeline was returned to its normal operating pressure at 17:15 on January 16, 2011.

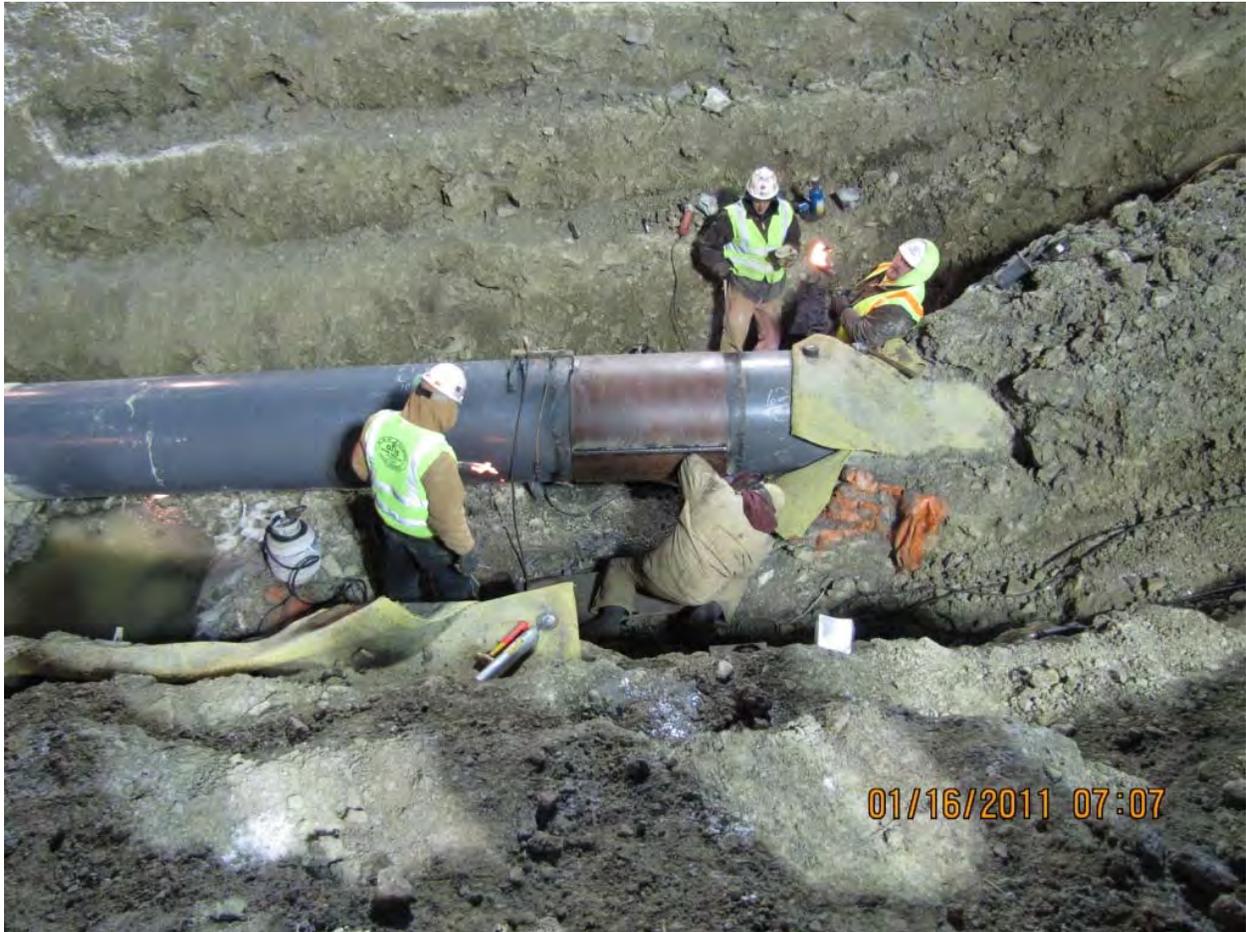
Repair sleeve being installed

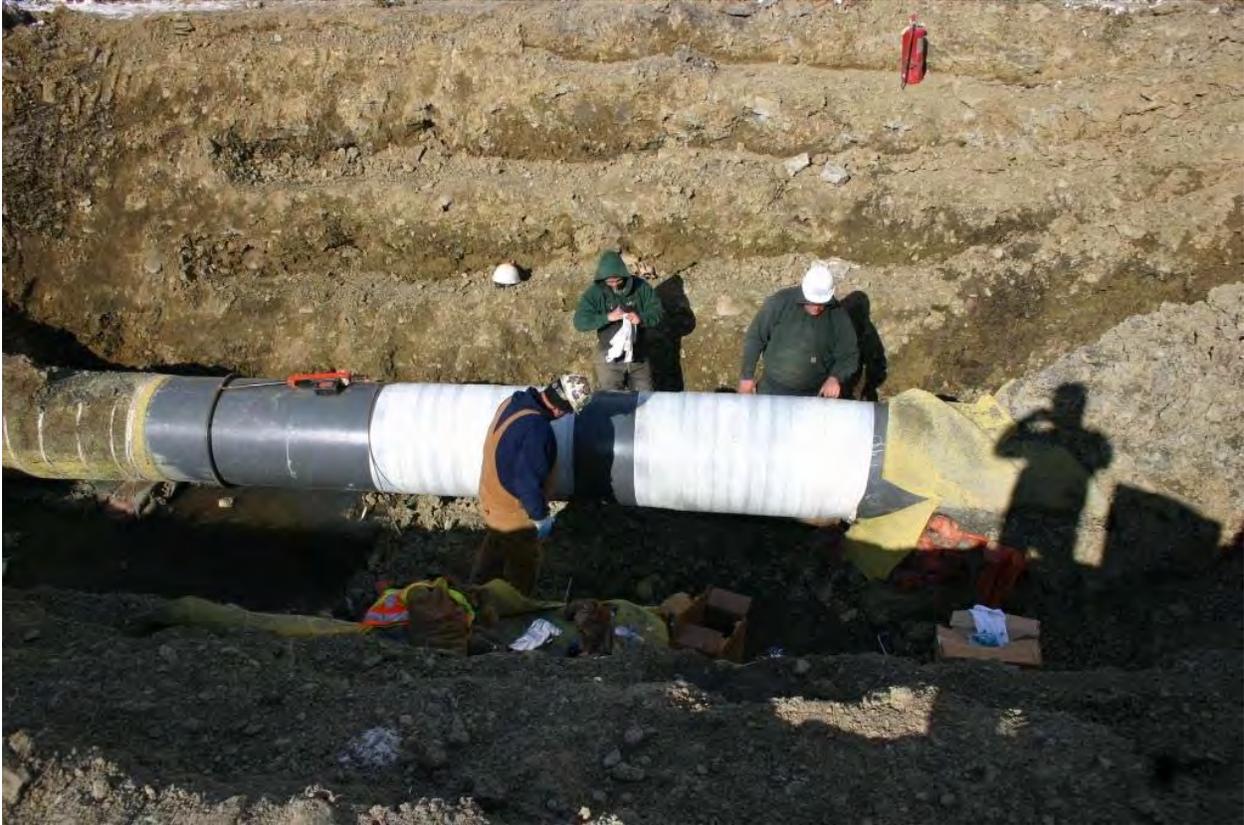
Tape wrap of repair sleeve
