Principal Investigator Chris Taylor
Region Director Wayne T. Lemoi
Date of Report March 21, 2013
Subject Failure Investigation Report – Tennessee Gas Pipeline Line 100-1,
Batesville, Mississippi

Failure Investigation Report – Tennessee Gas Pipeline Line 100-1 Rupture, Batesville, MS

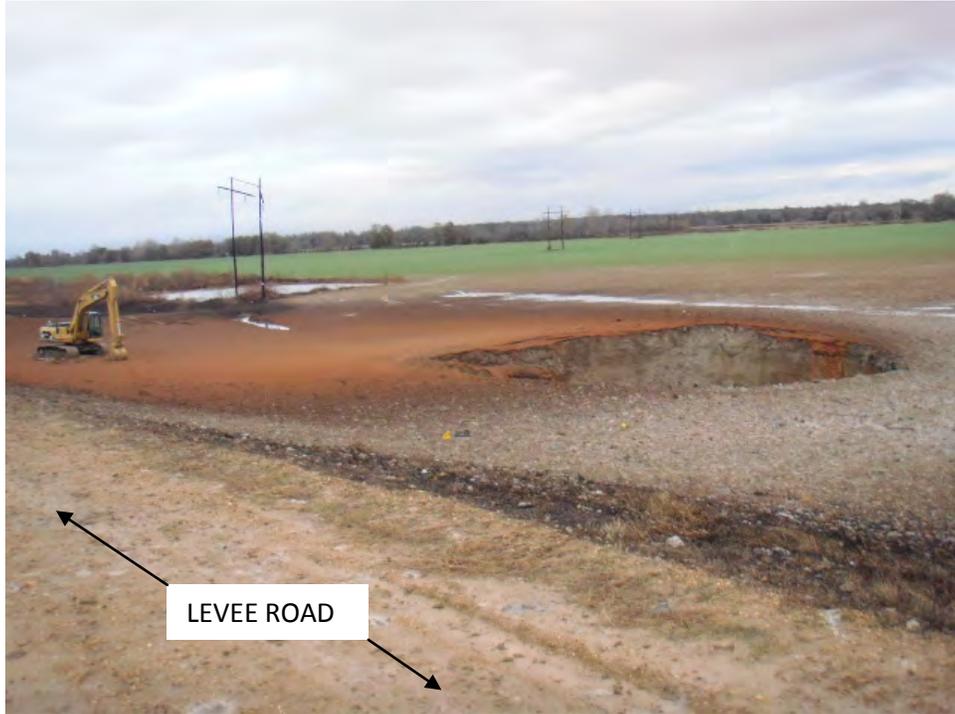
The high pressure natural gas escaping from the failed repair sleeve displaced the soil, formed a crater approximately 78 feet in diameter, and exposed approximately 40 feet of the 24-inch pipeline. The depth of cover at this location was approximately 12 feet.

Figure 6. The Line 100-1 rupture resulted in a 78-foot diameter crater. The ensuing fire burned a wooden high voltage tower owned by Entergy Mississippi (left of crater).

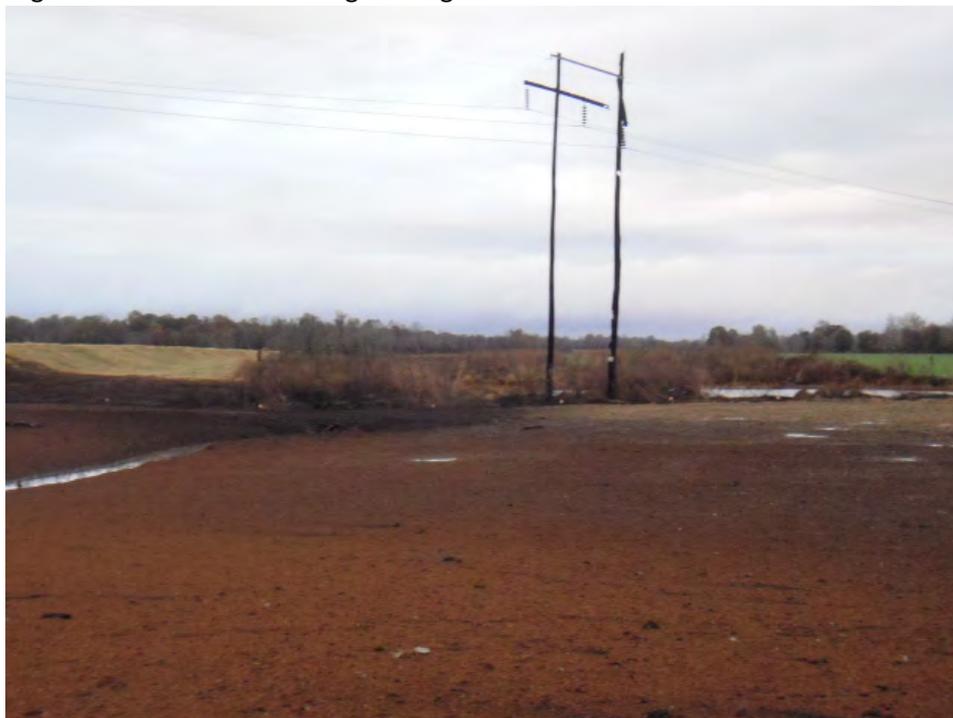
Figure 7. Burned wooden high voltage tower

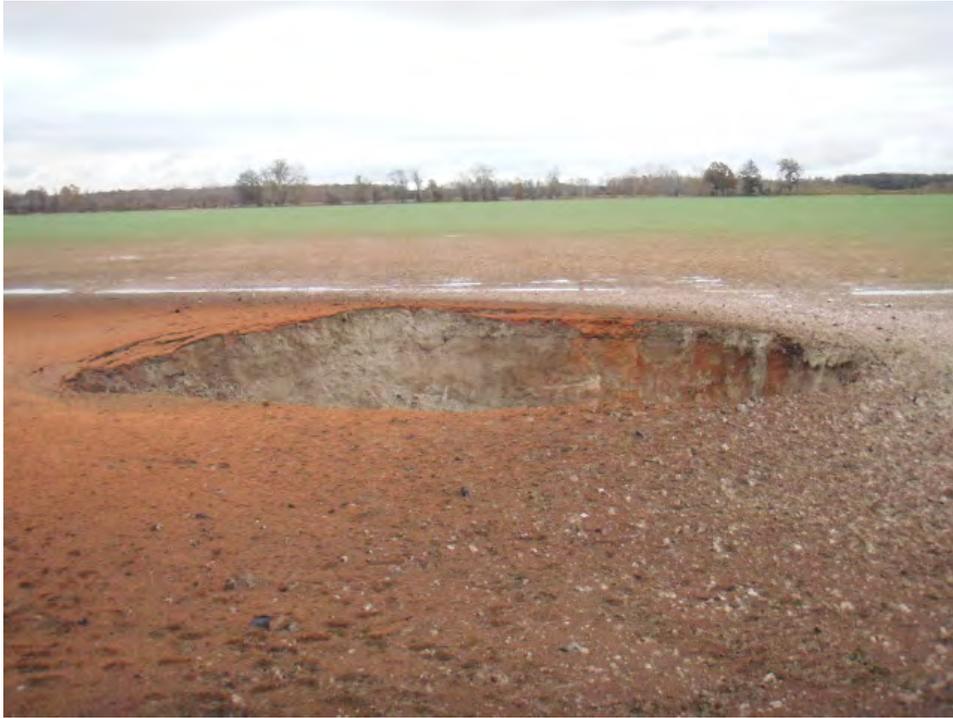
Figure 8. West of crater – facing east is the Line 100-1 right-of-way direction

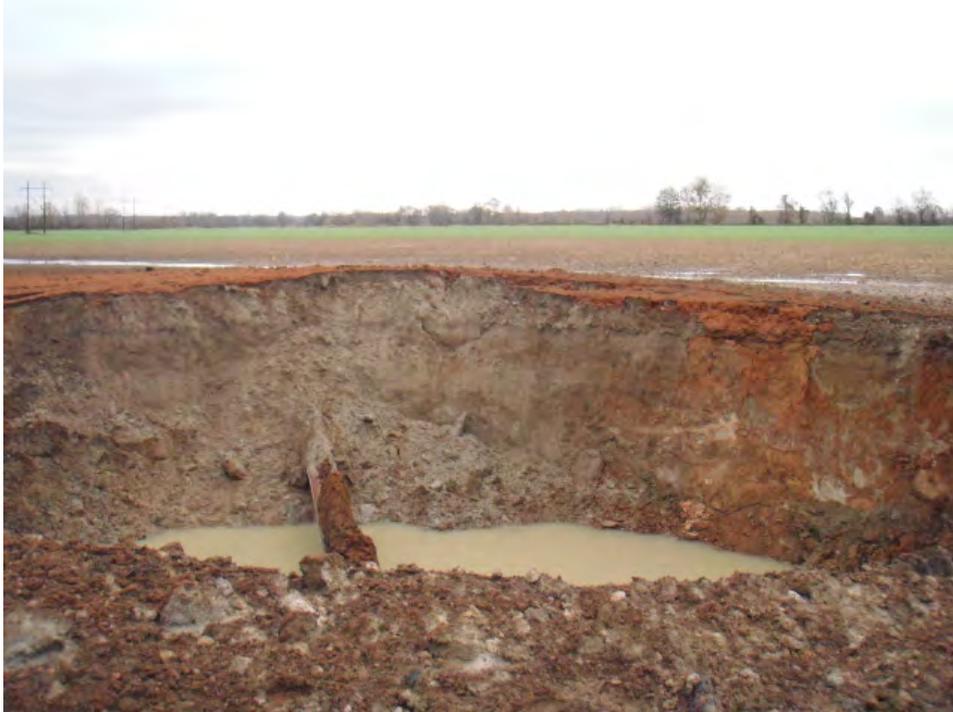
Figure 9. Closer view of the Line 100-1 pipeline within the crater facing east

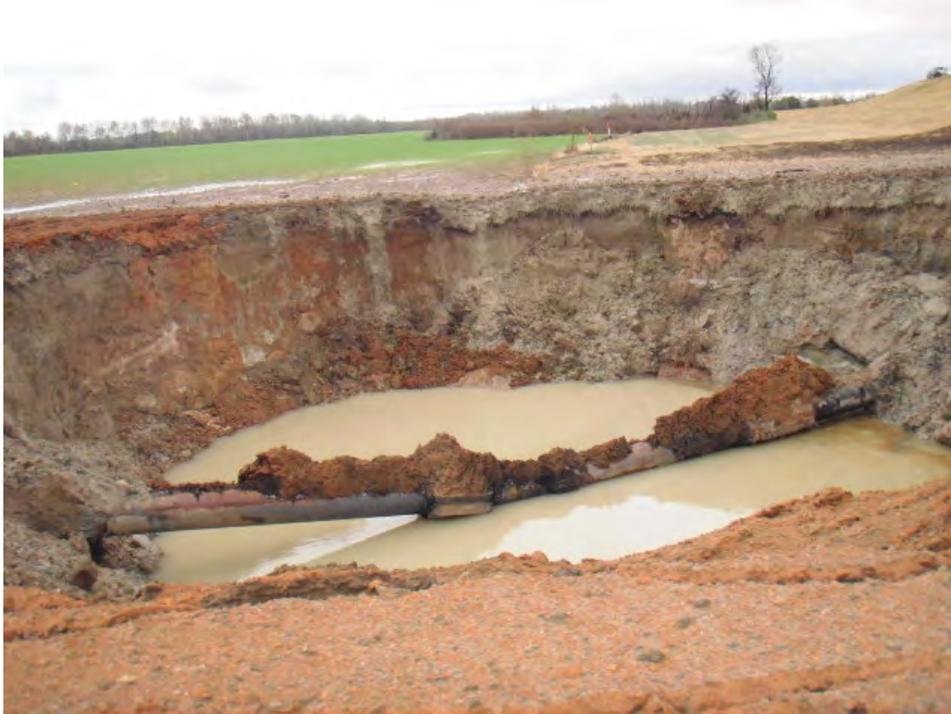
Figure 10. Standing north of crater - gas flow from the Batesville Compressor Station was right to left (from approximate southwest to northeast). Batesville Compressor Station was approximately 2 miles upstream of the failure location.

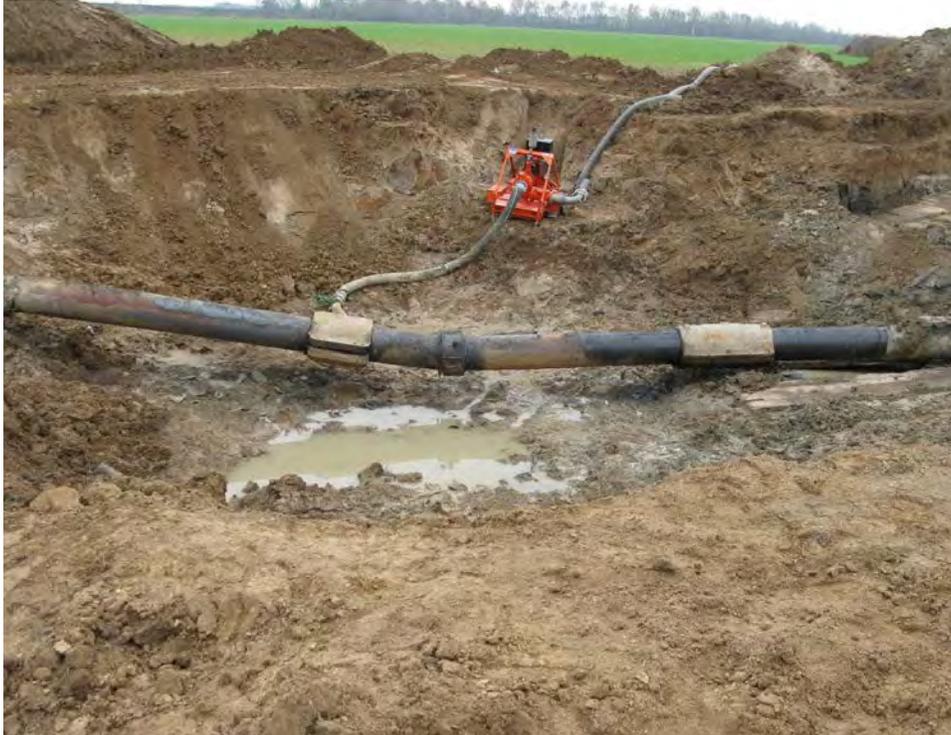
On November 22, 2011, the PHMSA inspector arrived at the failure site and, accompanied by TGP personnel, observed Line 100-1 intact, with the exception of a failed welded repair sleeve. The repair sleeve, which failed at the 6 o'clock pipe position, was one of five features along this pipeline in the failure area. The additional features, including the failed repair sleeve, were as follows (upstream to downstream – see Appendix A, Figures 11 and 12):

- River weight
- Wrinkle bend in an under-bend configuration
- Failed welded repair sleeve
- Wrinkle bend in the under-bend configuration
- River weight

Figure 11. Standing north of crater – Positioned right to left on the pipeline in this photograph, is a river weight, a pipe wrinkle (indistinct in this view) , a failed 1946 vintage welded repair sleeve, a pipe wrinkle (indistinct in this view), and a river weight.

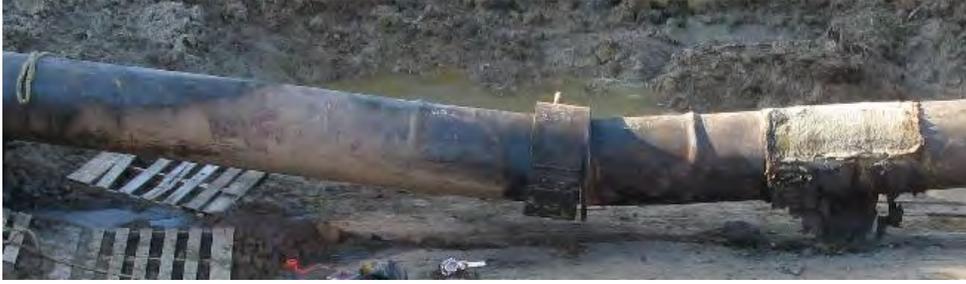
Figure 12. Standing south of crater - Zoomed view of the failed 1946 field fabricated welded repair sleeve and adjacent wrinkle bends (gas flow from left to right).

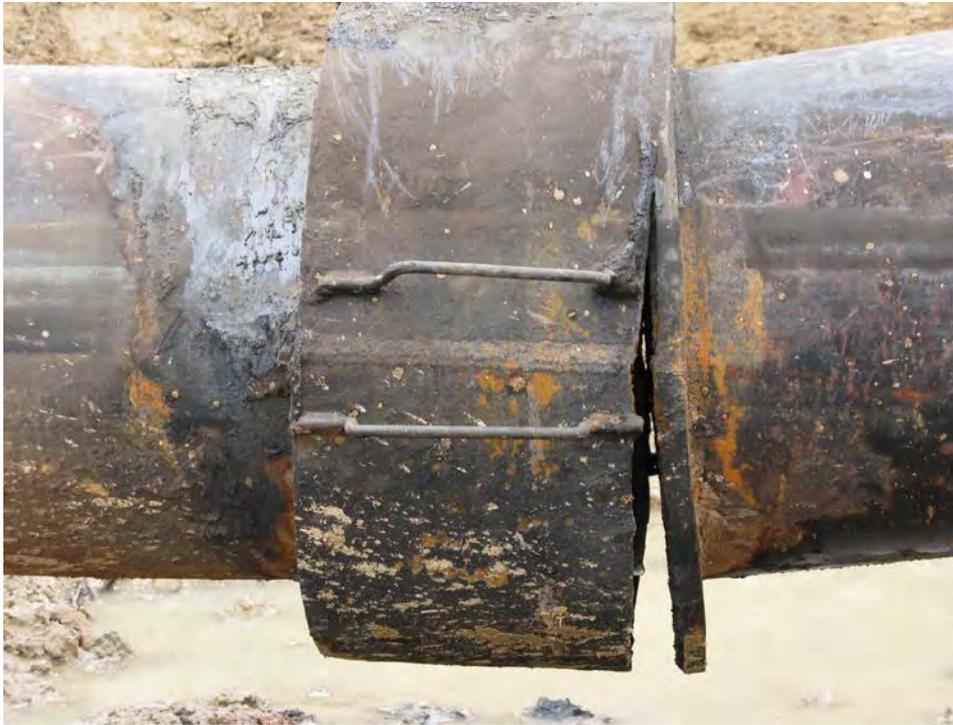
The carrier pipe failed at this location due to *"cumulative bending and axial overload stresses"* that created through-wall cracks at the toe of the fillet weld's¹⁸ heat-affected zone. Higher steel hardness was measured at the heat-affected zone compared to a lower average hardness measured at the repair sleeve, weld metal, and pipe base metal.

Figure 13. Zoomed view of welded repair sleeve from south of crater, showing the 6 o'clock failure location. The carrier pipe failed at the same 6 o'clock position.

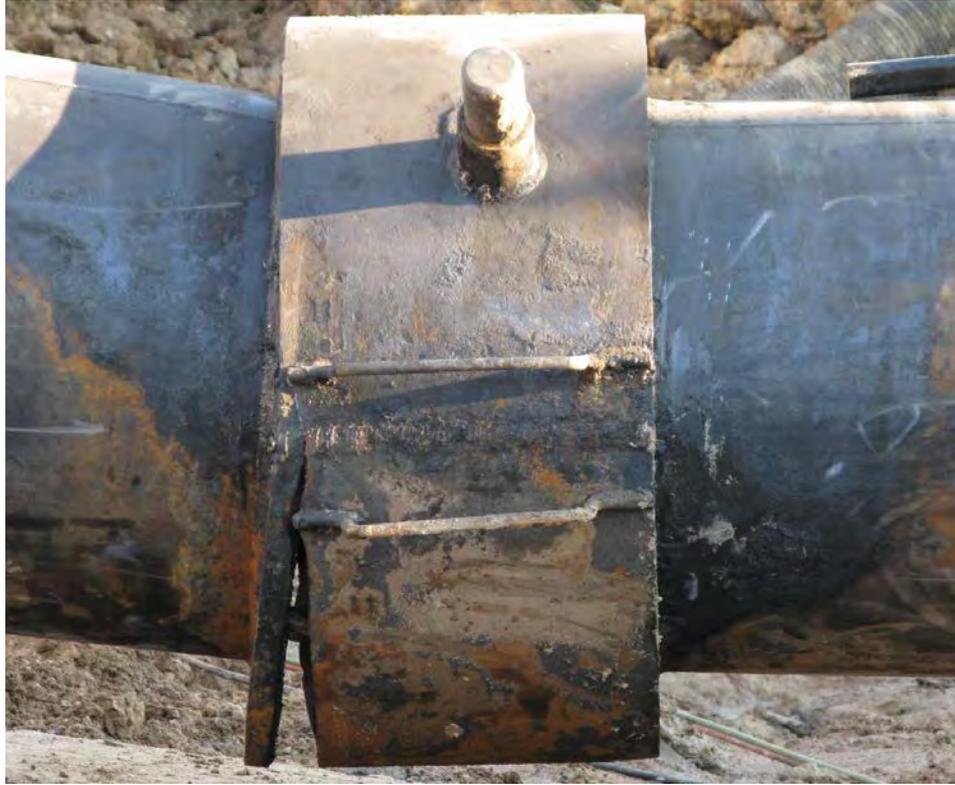
Figure 14. Zoomed view of welded repair sleeve. The sleeve was installed over a barely visible leak clamp and a previously repaired failed wrinkle bend. A 2-inch pipe nipple and bull plug are shown.
