Principal Investigator Chris D'Souza
Senior Accident Investigator Michael Yazemboski
Region Director Byron Coy
Date of Report 7/12/2013
Subject Failure Investigation Report – Williams Gas Pipeline-Transco-
North Bergen, NJ, 72nd Street Interstate Trans Lateral Leak

Williams Gas Pipeline-Transco; North Bergen, NJ, 72nd Street Interstate Trans Lateral Leak
Failure Date: 4/2/2012

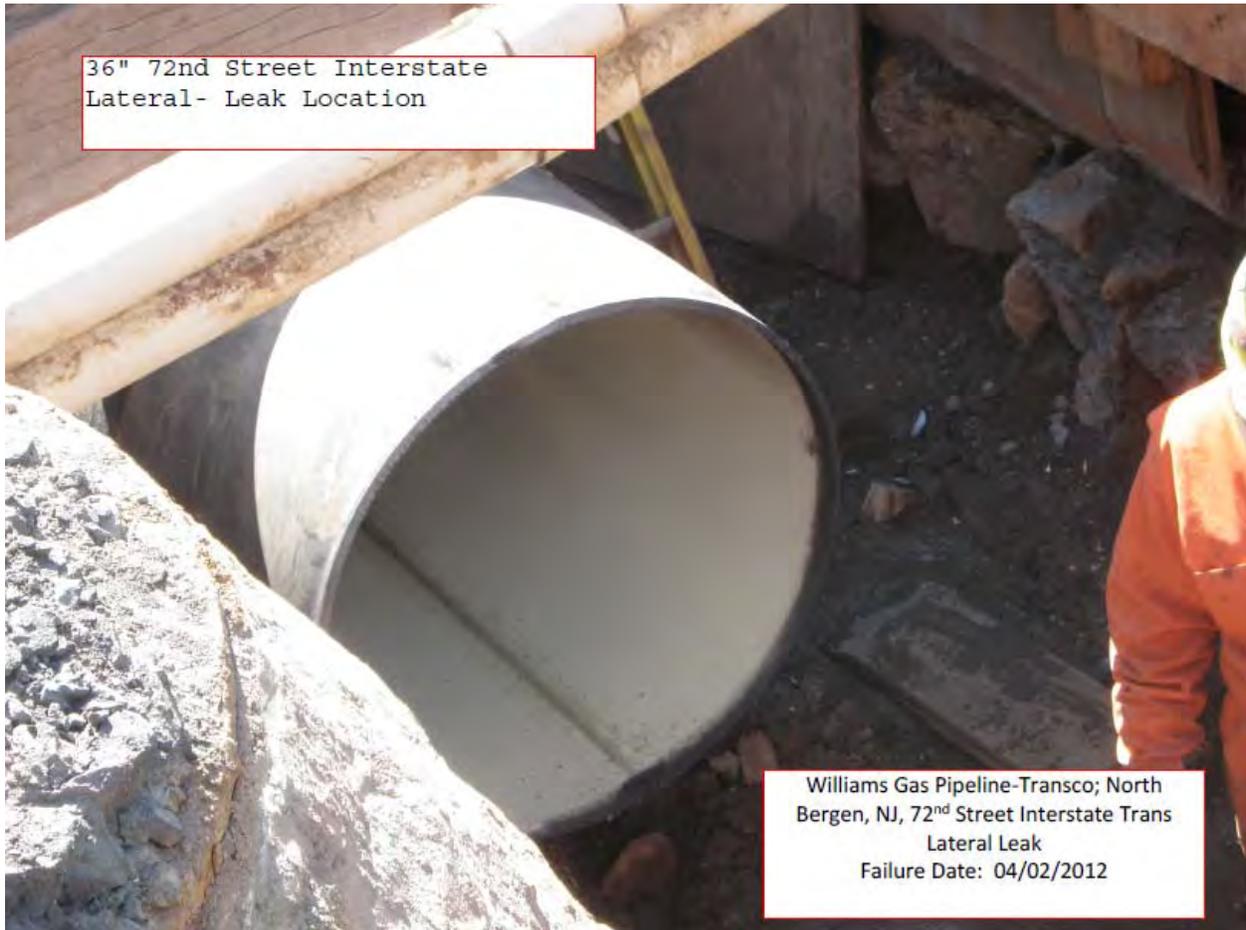
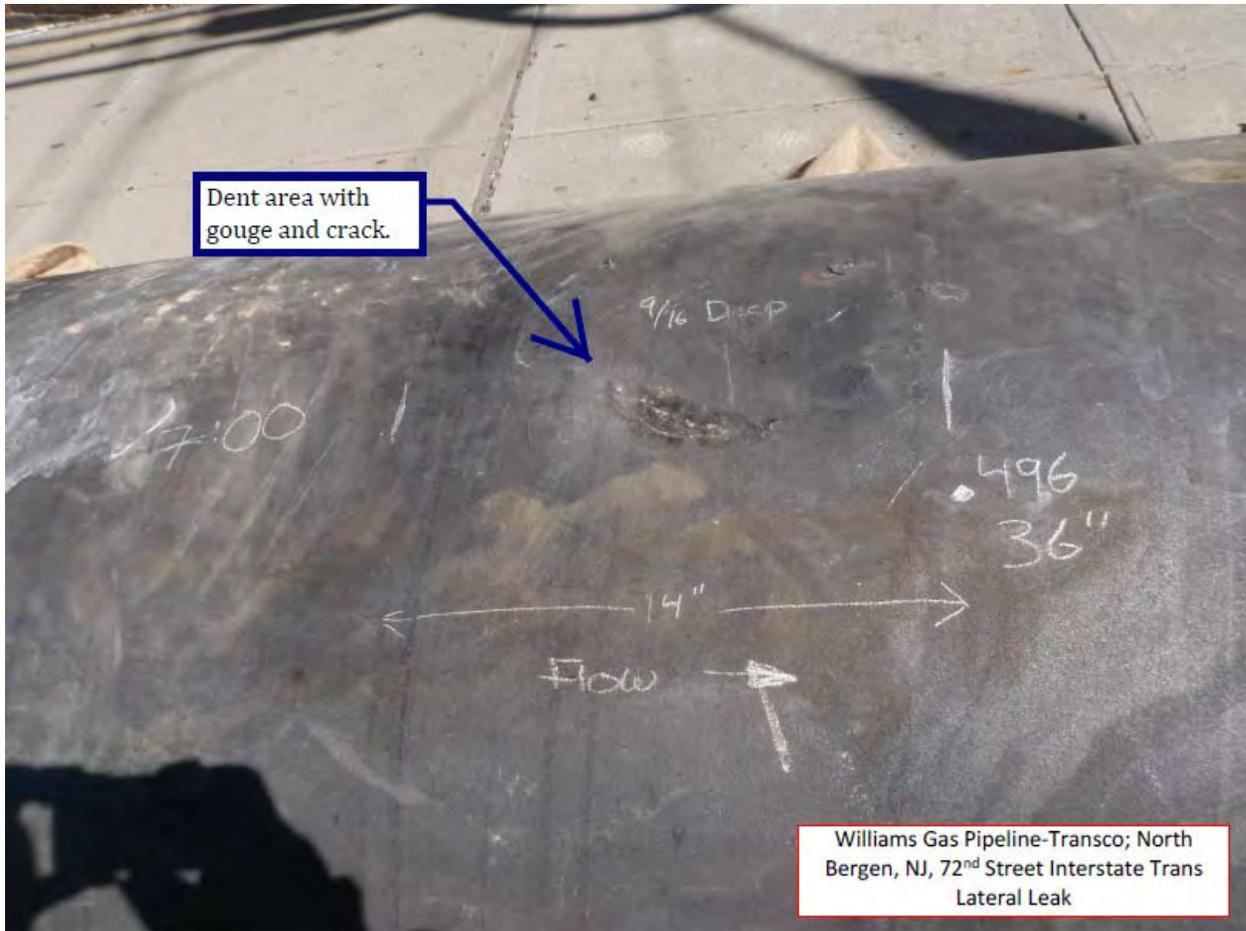
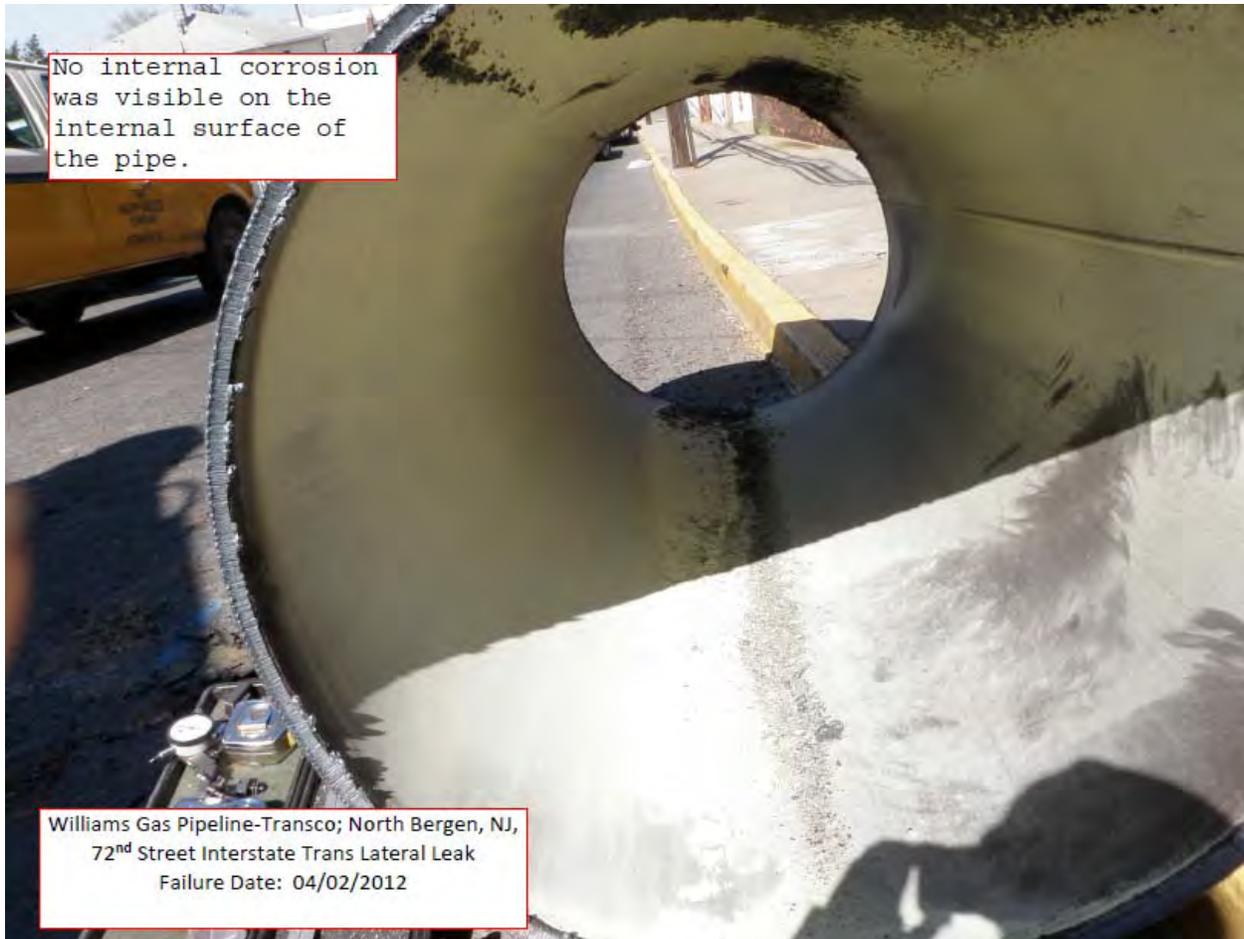
139107 Appendix B - Photos

A visual inspection of the dent and the surrounding area showed no signs of external corrosion. The pipe coating appeared to be in good condition with no disbonding (except where the rock contacted the pipe) (Appendix B-Photos).

The cause of the leak was due to a rock impinging against the pipe wall at approximately the 7-o'clock position, which resulted in a 1.5 percent dent measuring 14 inches long and 8 inches wide. The dent contained a slight gouge with a crack.

Approximately 7 feet of pipe containing the dent and crack was removed from the pipeline. An additional 6 feet downstream of this section was also removed to accommodate the tie-in. The final tie-in was made on April 5, 2012, and the line was returned to service.
