DOT US Department of Transportation
PHMSA Pipeline and Hazardous Materials Safety Administration
OPS Office of Pipeline Safety
Eastern Region

Principal Investigator Alex Dankanich
Region Director Byron Coy
Date of Report November 12, 2014
Subject Failure Investigation Report – Buckeye Macungie Tank 228 Overfill

Failure Investigation Report – [Buckeye Pipeline – Tank 228 Overfill]

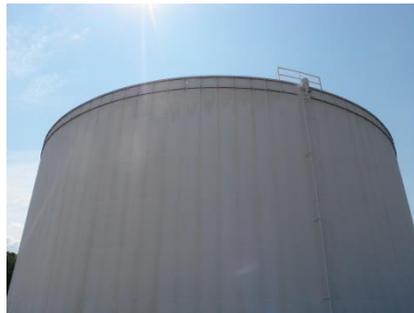
Tank 228 is an atmospheric low pressure breakout tank measuring 110 feet in diameter by 48 feet high, and it has an internal floating roof and a steel cone roof (Appendix A-page 3-4). Tank 228 was constructed in 1974 and is equipped with a tank level alarm system comprised of a GSI system and Hi-Hi Level Switch. The GSI is a software-based system that receives data from the tank side gauge, encoder, and transmitter mounted on the tank. The Hi-Hi Level Switch is located on the roof of the tank.
